1914 West Kings Highway
Certificate of Appropriateness Application
Siding Existing Conditions Survey
Submitted: 5/14/2025

1914 W Kings Hwy
Exterior Conditions Survey

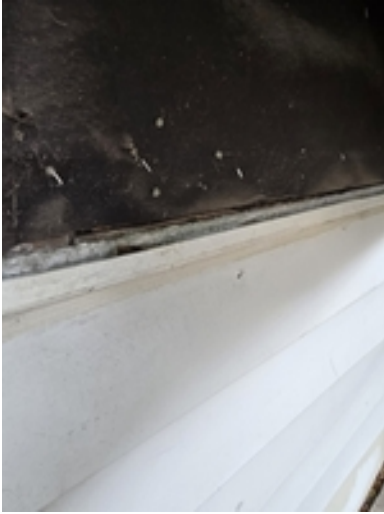
Location: Near Kitchen Door

Notes: Vinyl siding is pulled up, exposed felt barrier behind. Improper termination of felt has led to potential moisture intrusion

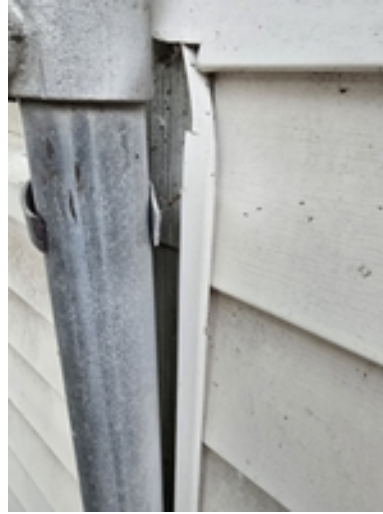
Location: Outside of Guest Room

Notes: Asbestos tile observed behind gap in vinyl siding.

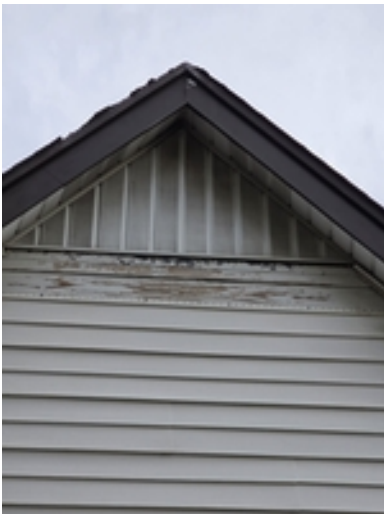
Location: **Front face of house**

- Storm damage has ripped top vinyl panel & moulding off.
- Exposure to outside conditions has deteriorated wood
- Original wood lap siding exposed.

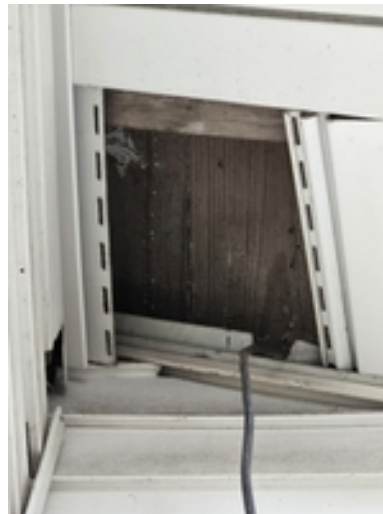
Location: **Exterior of Guest Room (soffit)**

- Gap in siding has exposed wooden eaves
- Pest intrusion concern

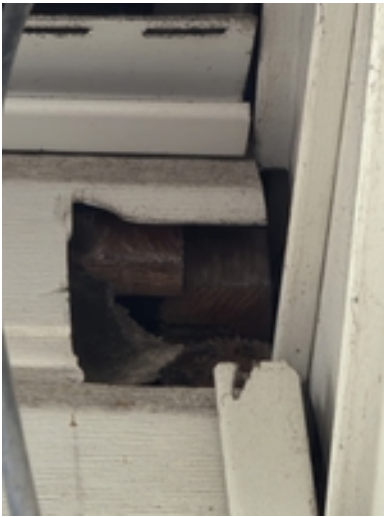
Location: **Exterior of Guest Room (wall)**

- Gap in siding exposes interior framing
- Felt barrier is ripped, frayed, and has ~3" gap

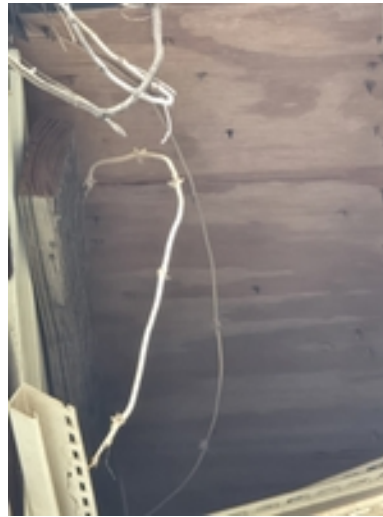
Location: **Exterior of Master Bedroom (soffit)**

- Vines have crawled up through pockets between sheathing & siding.
- Exposed roof underlay is less weathered than in other areas of the house, suggesting a more recent addition.

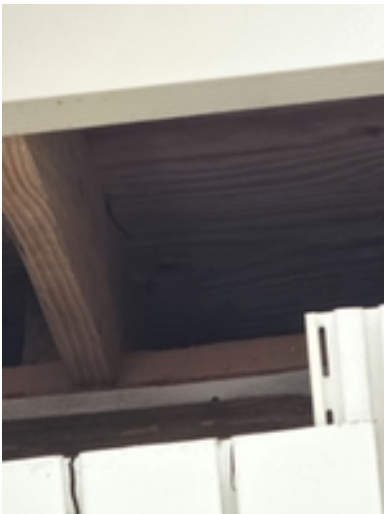
Location: **Exterior of bathroom (soffit)**

- No air/ vapor barrier present.
- Large cracks in drywall from interior portion, can see sunlight through the cracks
- Soffit is falling off or not present

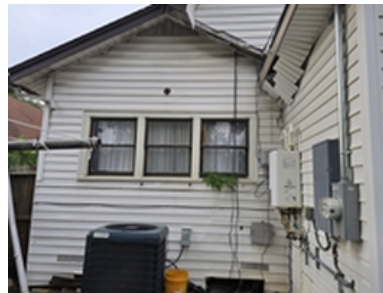
Location: **Exterior of Master Bedroom**

- Multiple abandoned wiring, conduits, pipes, boxes.
- Previous repairs to spray expansive foam in large 4" diameter penetrations into exterior
- Vines have crawled up through pockets between sheathing & siding.
- Multiple vinyl soffits are failing or have already fallen off.
