## **Visual Assessment, Lead-Based Paint Inspection**

**112 Armour Place**

**San Antonio, Texas 78212**

**Date of Inspection: October 16, 2024**

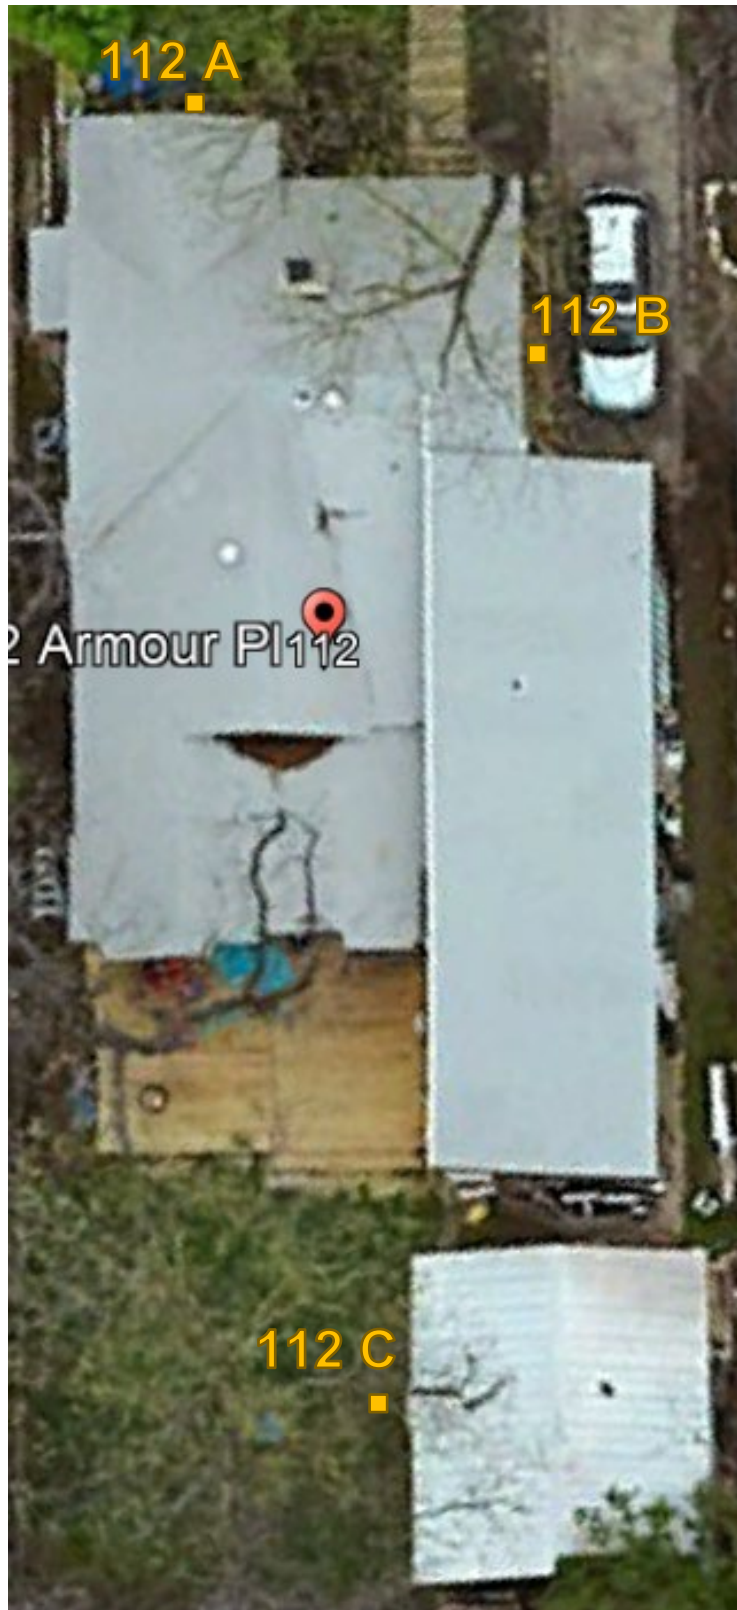
I. Soil Sample Location

Because of the deteriorated paint identified on the property, DEKD collected three soil samples from around the home and none of the soil samples were above the current HUD standard of 400 PPM (parts per million) for play areas and 1200 PPM for building perimeters. The laboratory report for the soil samples is attached.

<b>112 C</b>	<b>Side D Garage</b>	<b>13.6</b>	<b>400 ppm</b>
--------------	----------------------	-------------	----------------
