Ref: Structural Visual Review of Existing Accessory Building for Remodel

Sub: 264 E Lullwood Ave., San Antonio, TX 78212

Project #: USE24-145

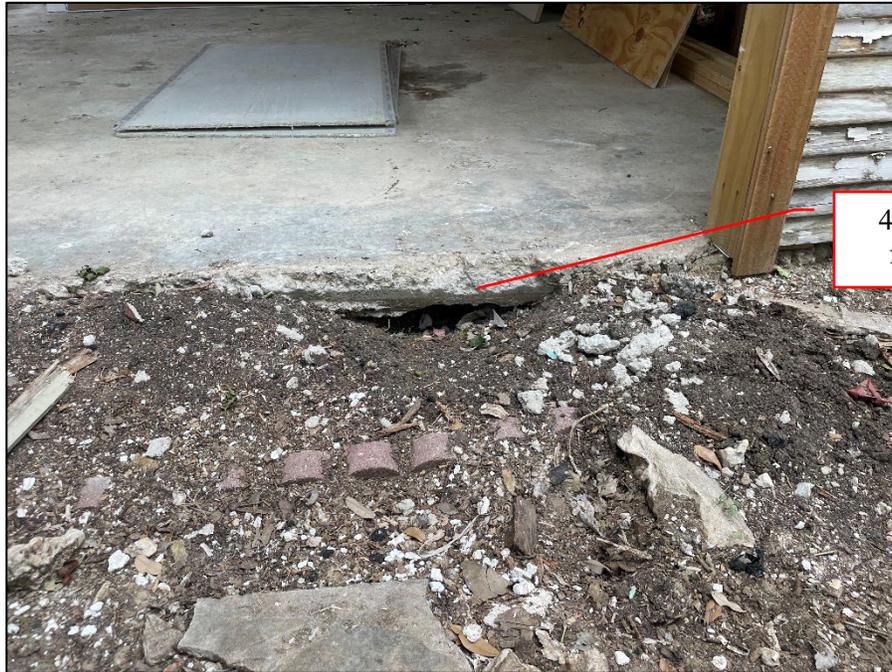
Photograph 1 – Right Side of Accessory Building

1. The 4” thick slab is not a structural slab and cannot provide adequate support for the accessory building.
2. The rear all appears to bear directly on the ground, not on a slab foundation. Therefore, the rear wall is not adequately supported.
3. The existing floor joists are insufficient to support the design loads due to the current span.
4. Concrete footings which bear into the existing ground are required to support the existing posts for the exterior stairs.

4" thick slab
foundation

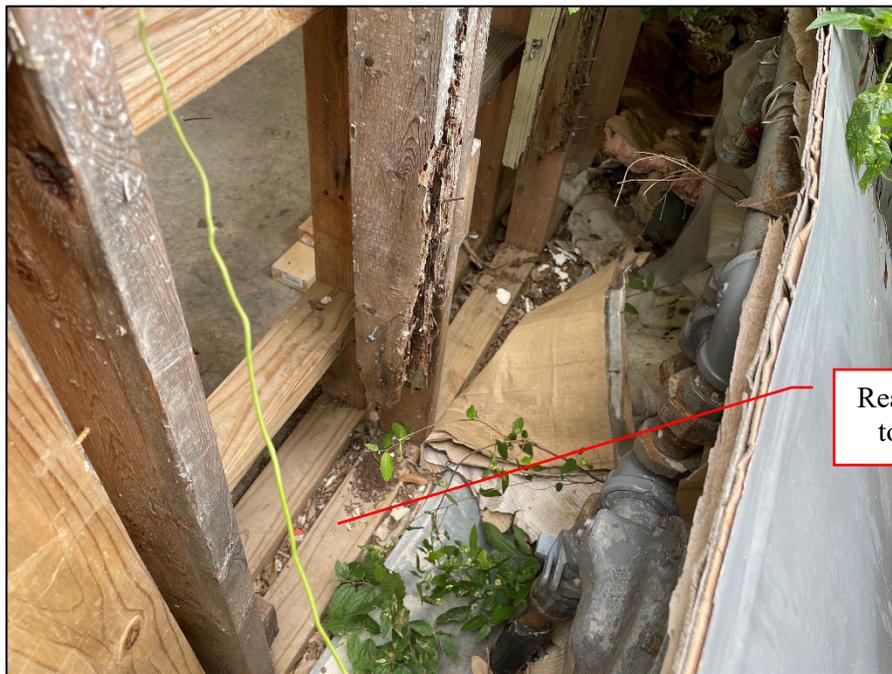
Photograph 2 – Rear Wall of Accessory Building

Rear wall appears
to bear on soil

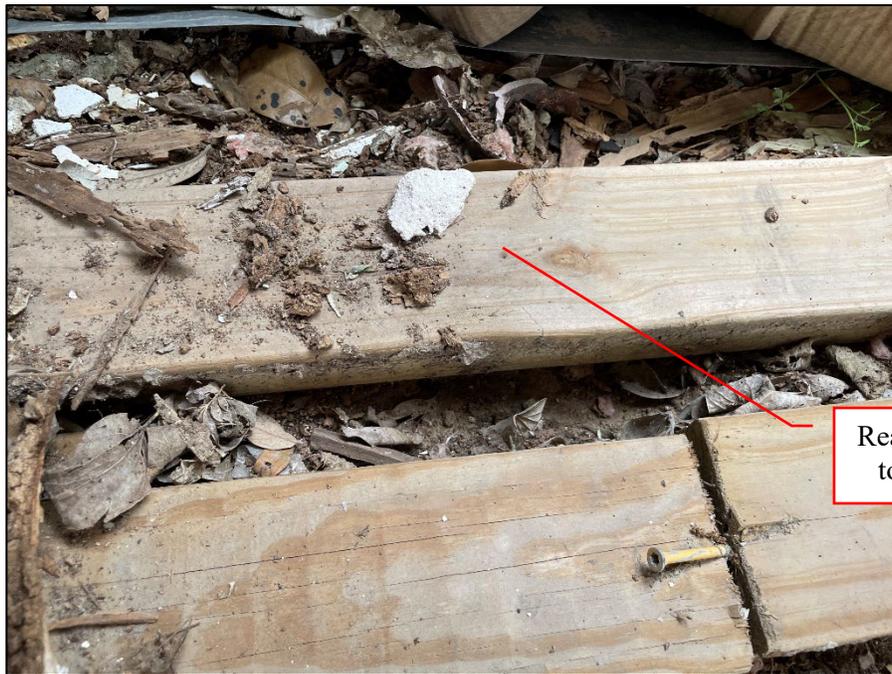
Photograph 3 – Rear Wall of Accessory Building

Rear wall appears
to bear on soil
