CONSULTANTS

**ENGINEERING INVESTIGATION OF A RESIDENCE
1002 KAMPMANN BOULEVARD
SAN ANTONIO, TEXAS**

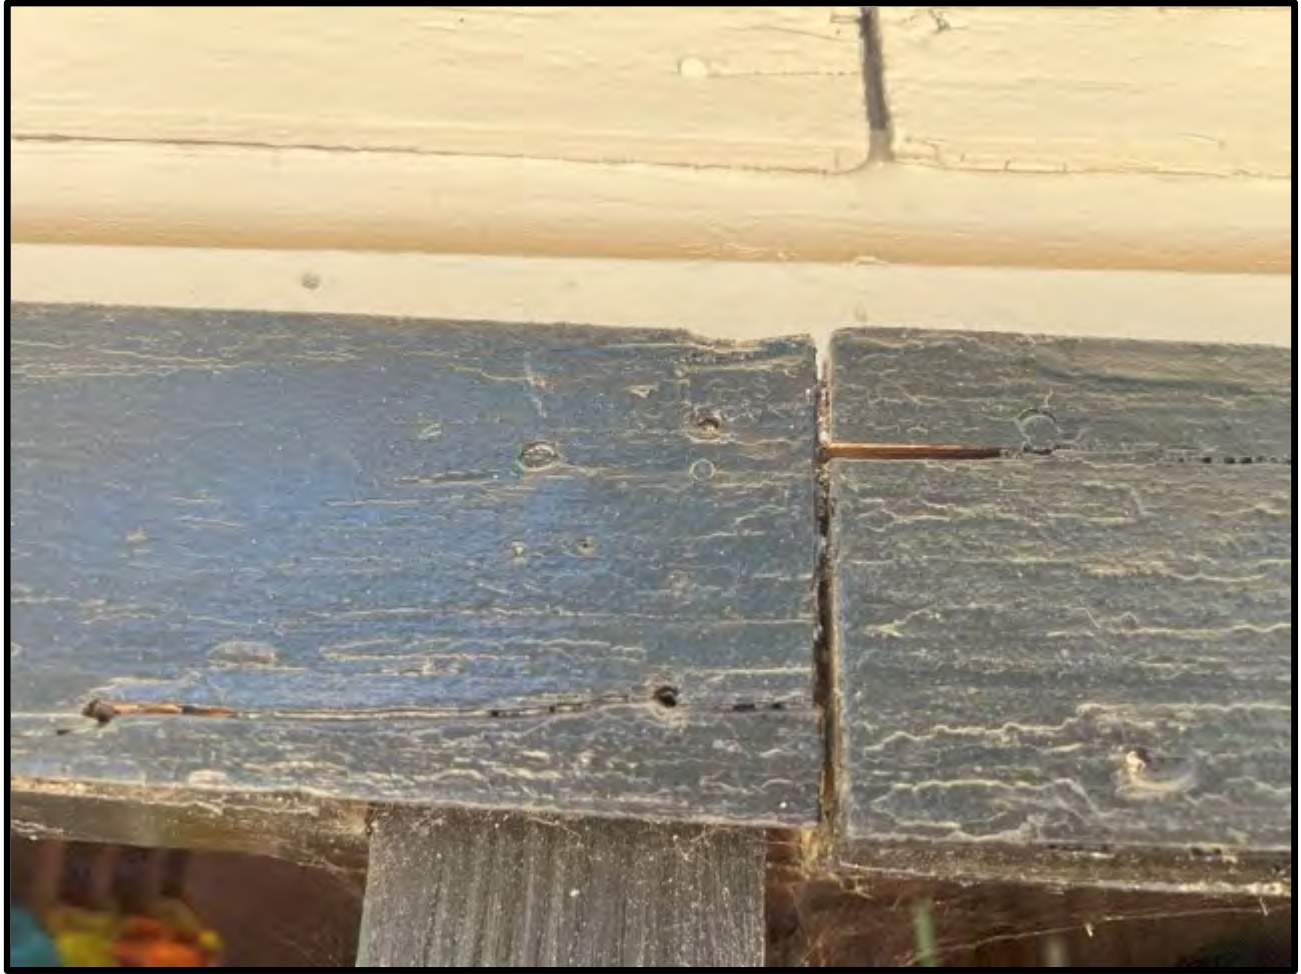
View of split cracks on the trims at the front (south) of the detached garage building.

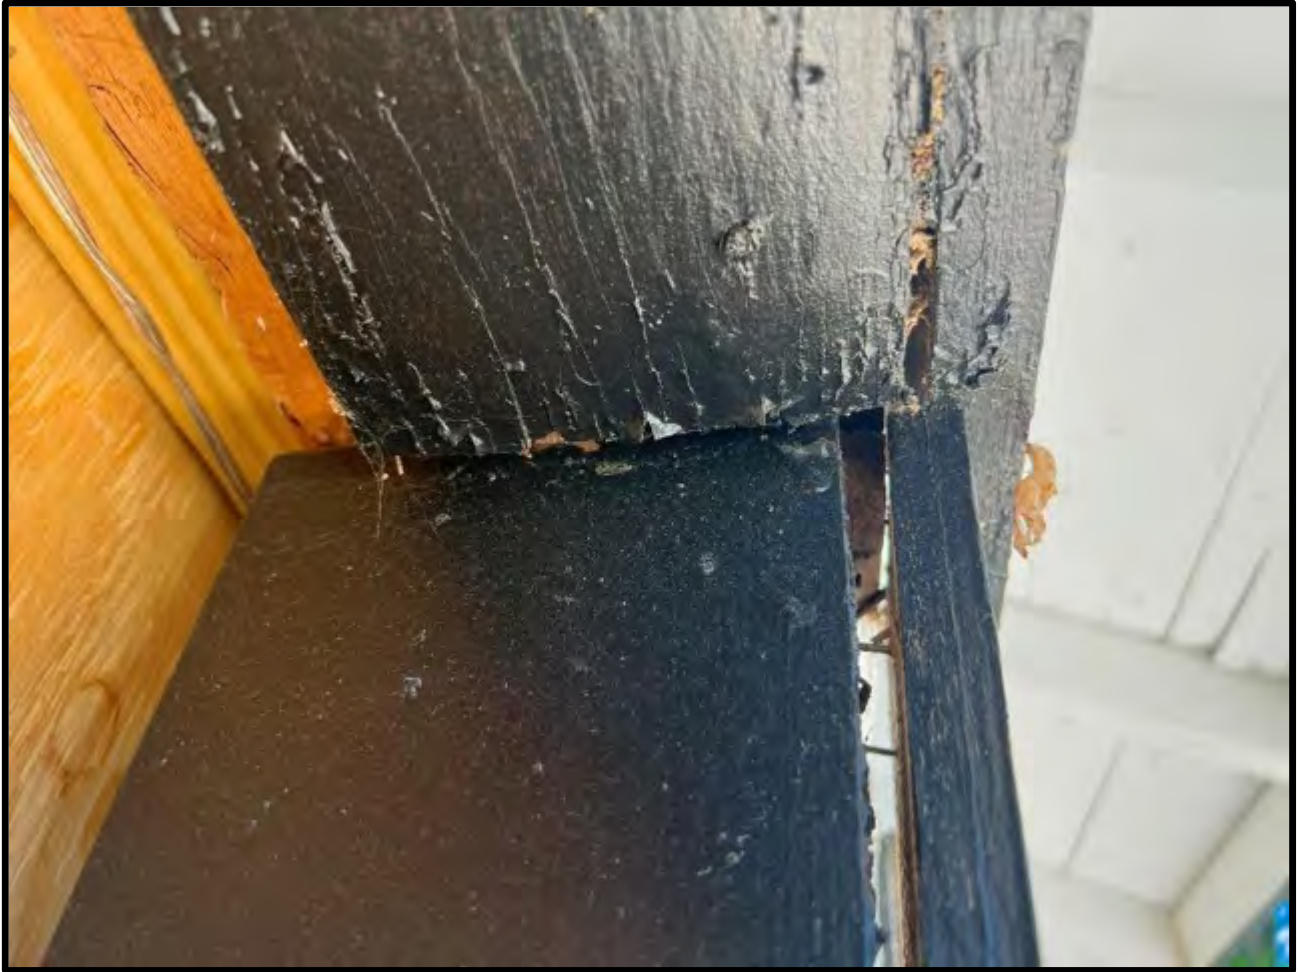
View of displaced frame and trim at the front (south) of the detached garage building.
