Residence
1614 E Houston St.
San Antonio, TX 78239

Structural Assessment – Fire Damage Report

Roof, Foundation and Framing Inspection, Fire Damage-1614 E. Houston St, San Antonio, TX.

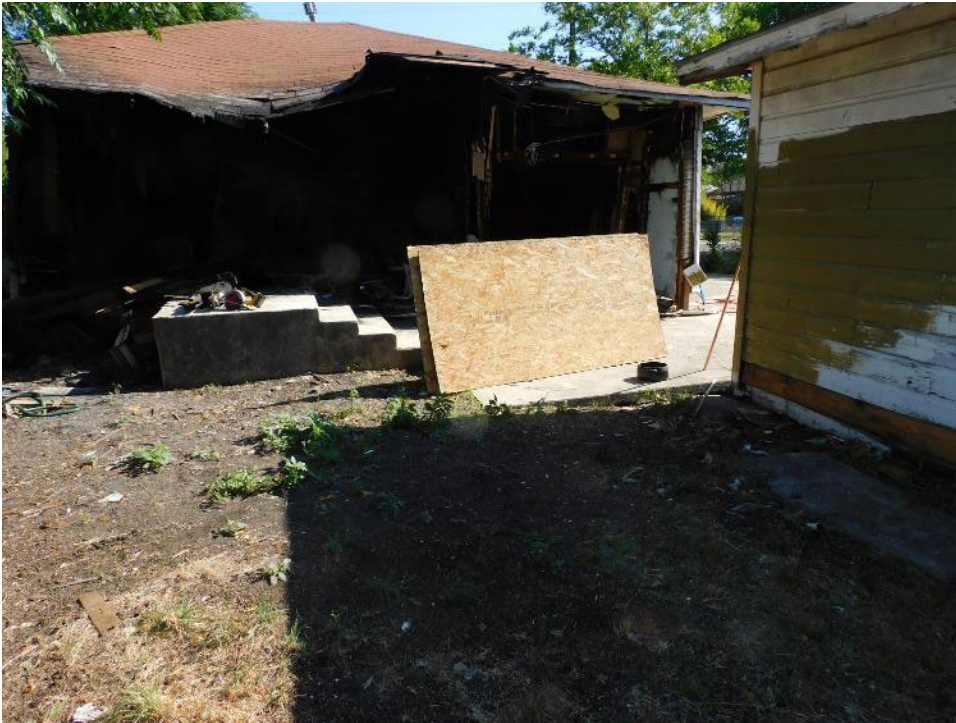
Photos 3, South (rear) elevation.

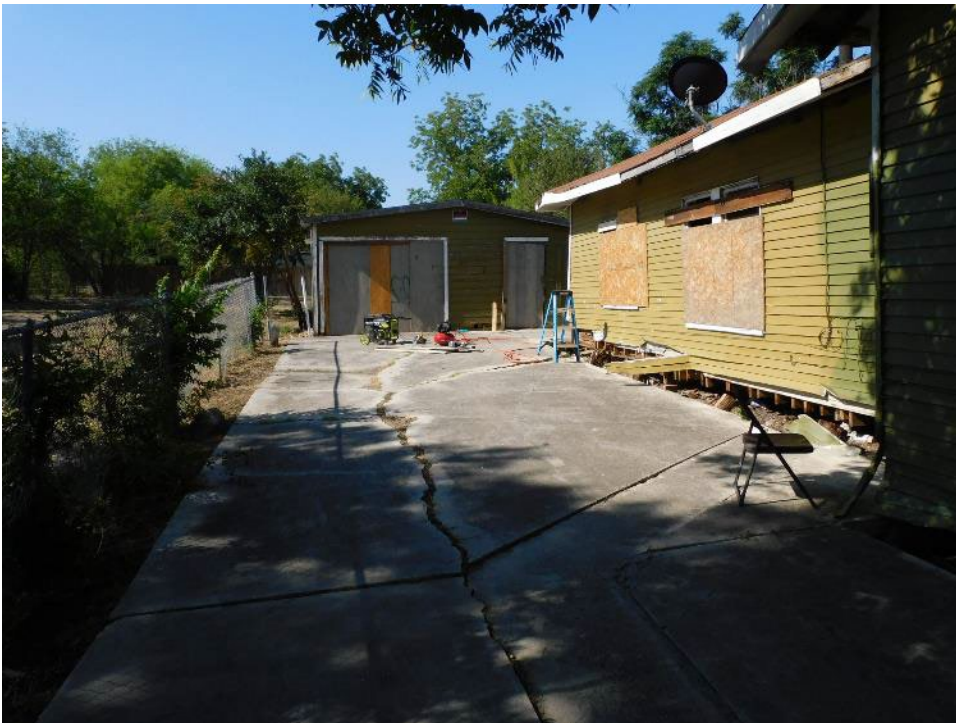
Photo 4, East elevation.

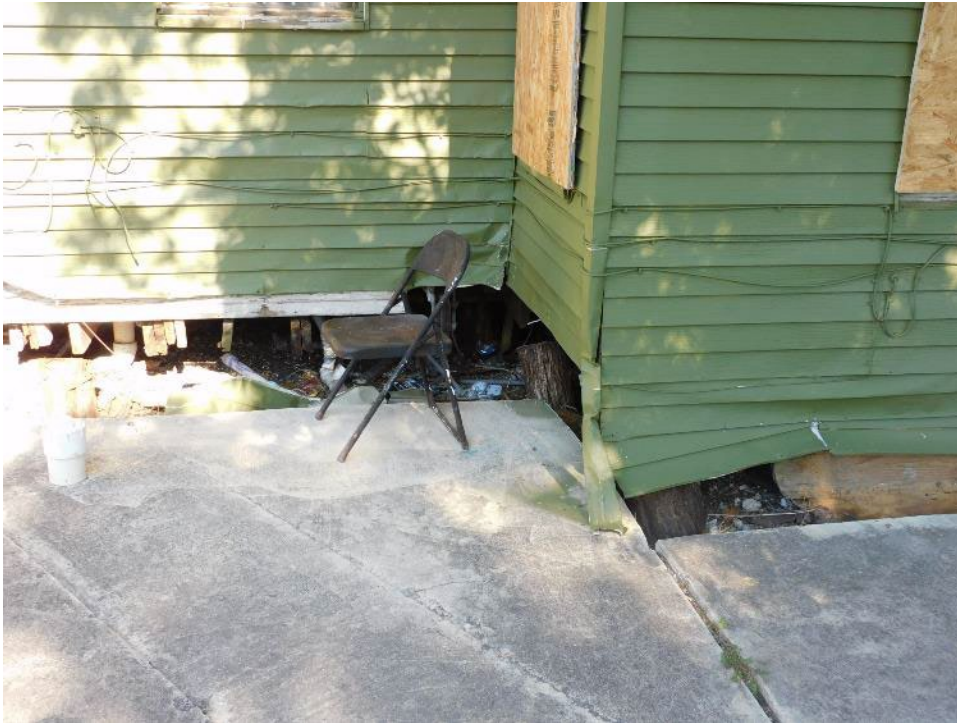
Photo 5, Exterior, damage to skirting and cladding, east elevation.

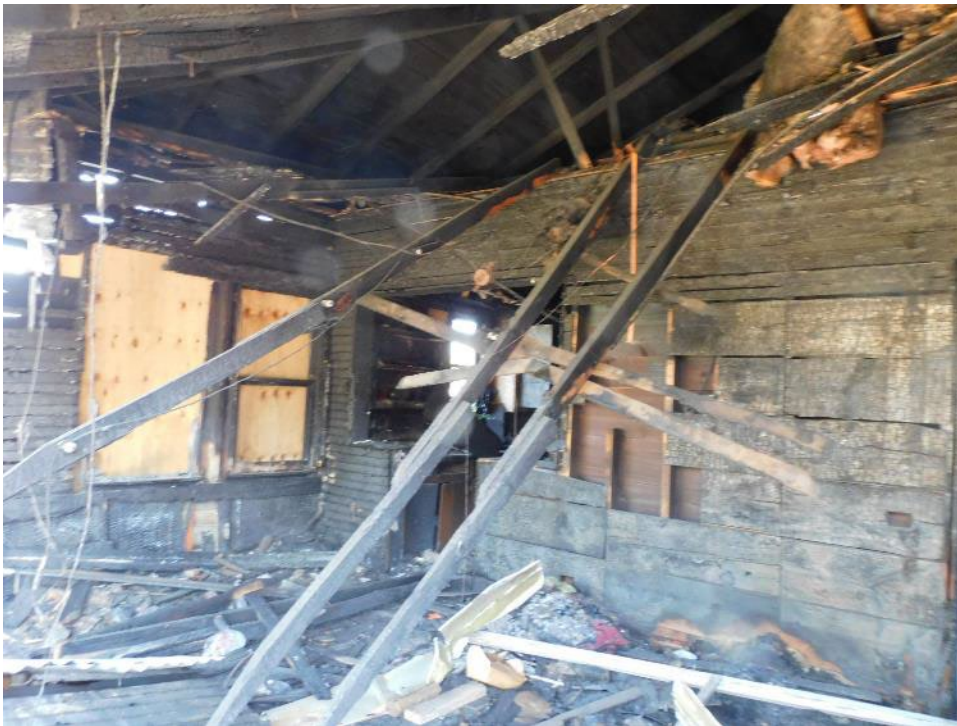
1. The rear walls and ceilings were severely damaged.
2. The damage consisted charring of the shiplap and wood walls studs.
3. The ceiling rafters and wood paneling was charred.
4. The fire damage extended from the rear into the front rooms.
5. The rear walls had collapsed, and the exterior rear wall was missing.
6. The floor deck was charred, buckled and missing sections.

Photo 6, Interior, damage to framing and walls.

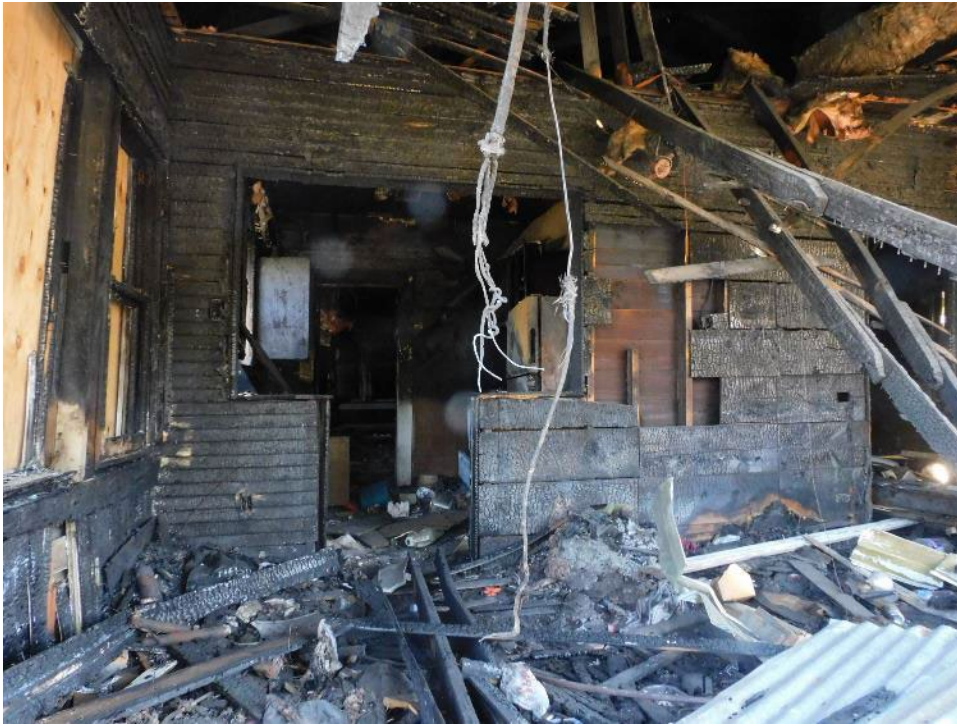
Photo 7, Interior, damage to walls and framing.

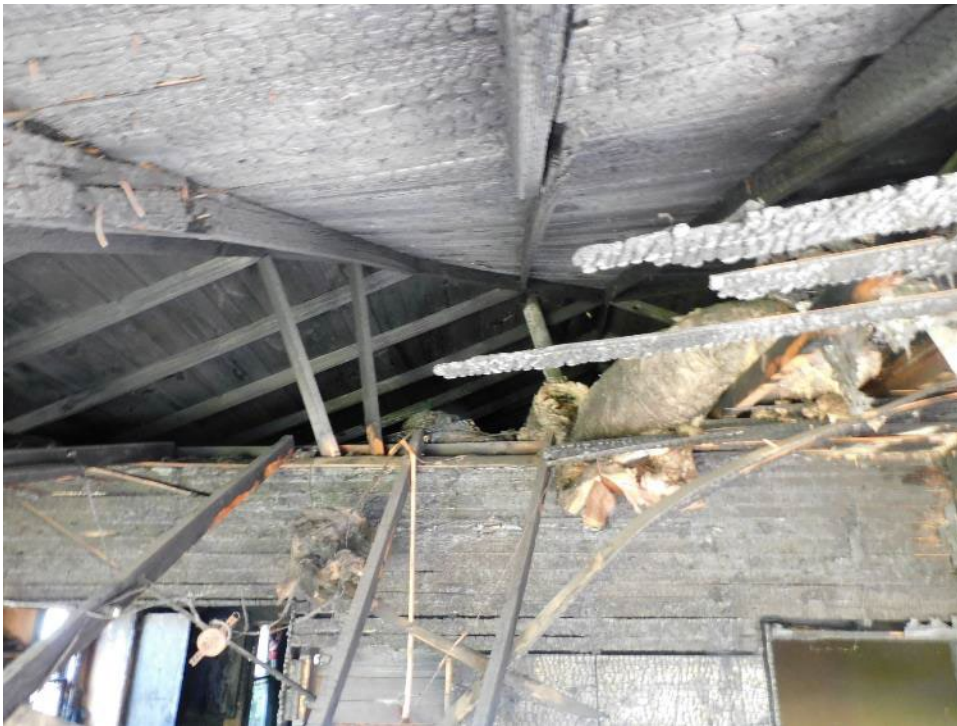
1. The roof framing consisted of rafter with purling bracing.
2. The rafters and purlin bracing were severely charred and damaged.
3. The rafters had collapsed at the rear and towards the front.
4. The roof deck was severely damaged and charred.

Photo 8, Attic, damaged roof framing.

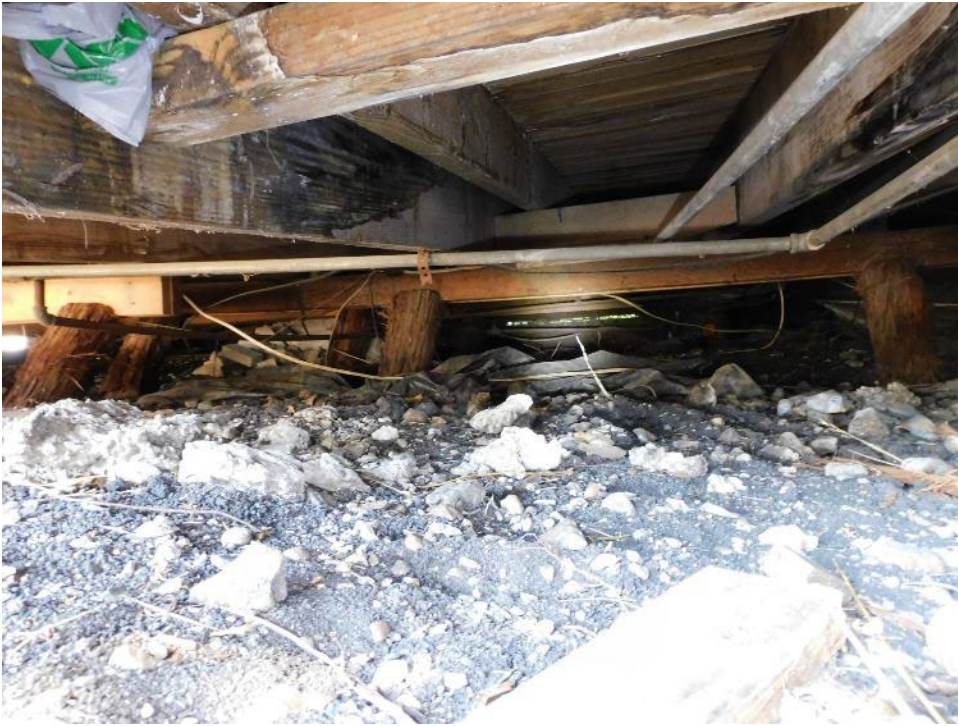
1. The foundation consisted of cedar post supporting wood beams and wood joists.
2. The cedar posts were toppled, tilted, or dislodged.
3. The wood beams were dislodged or tilted.
4. The wood joists were buckled and tilted.
5. The floor framing at the rear was severely damaged and charred.
6. An elevation survey was not conducted on the interior due to the conditions observed.

The foundation consisted of cedar posts supporting wood beams and wood floor joists. The existing foundation piers were found to be toppled, tilted, or dislodged. Based on the condition of the overall structure, we can reasonably conclude that the foundation has also been compromised and unsalvageable.

Photo 9, Crawlspace, toppled foundation piers.

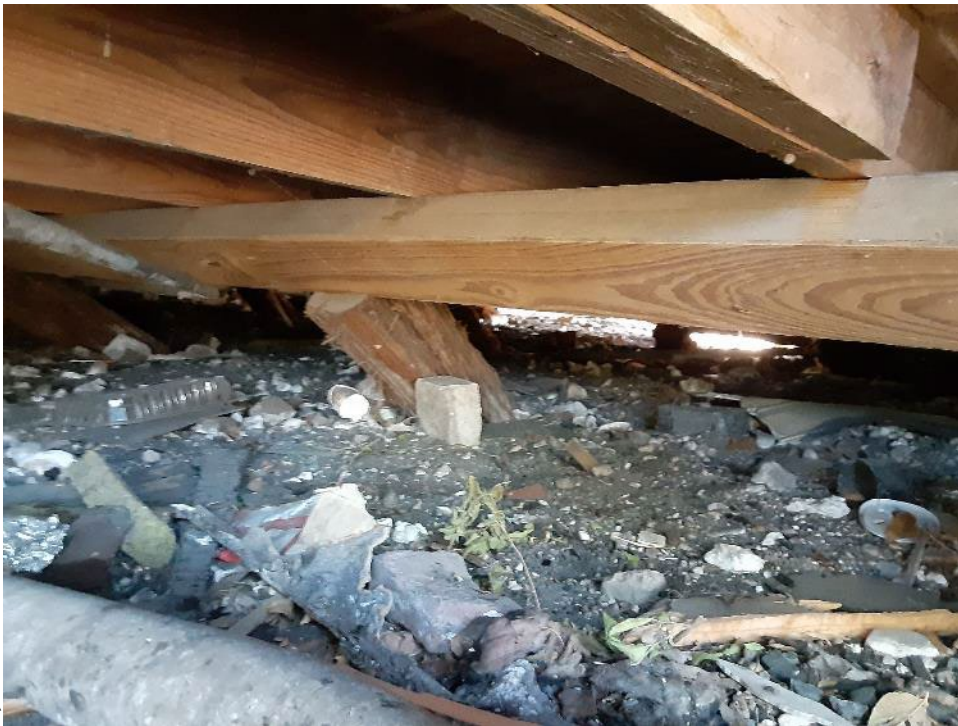
Photo 10, Crawlspace, toppled piers and rolled wood beam.

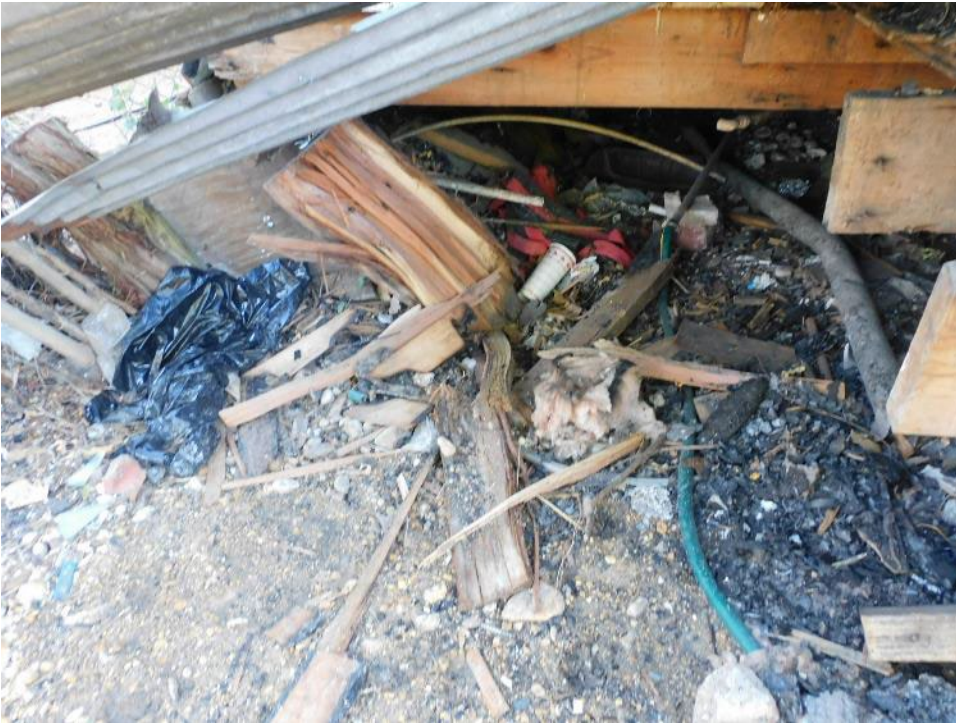
Photo 11, Crawlspace, damaged foundation pier.

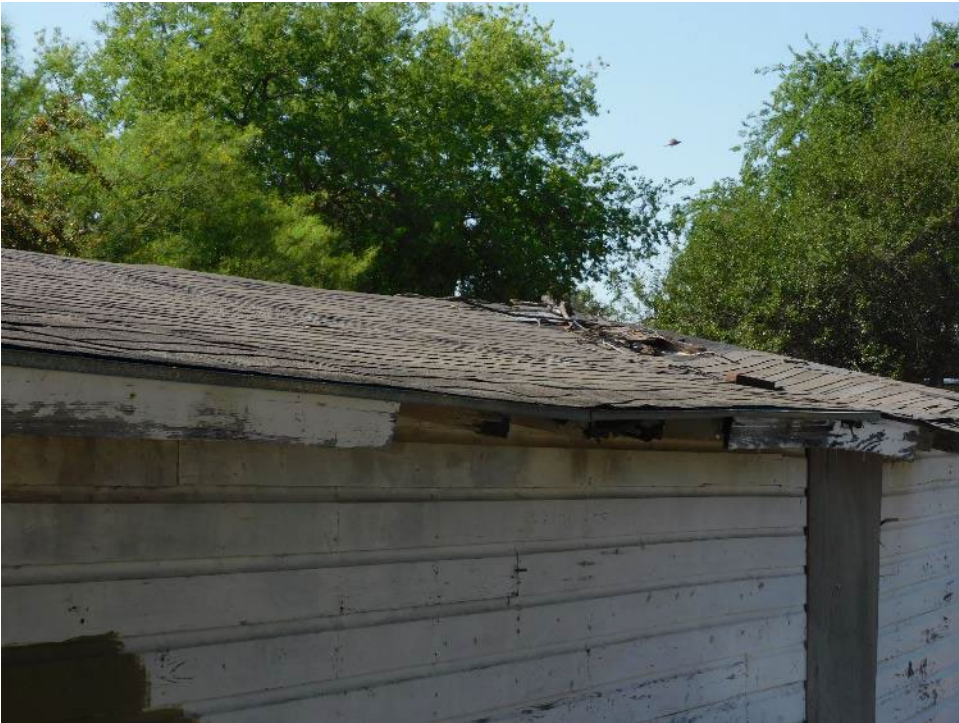
Photo 13, Exterior, garage roof.

As discussed, onsite, we recommend mechanical methods for the demolition of the structure for safety concerns. The structure should be considered "unsafe" and under no conditions should anyone enter the interior or access the roof. The existing conditions for the detached garage also warrant demolition and the same methods should be considered.

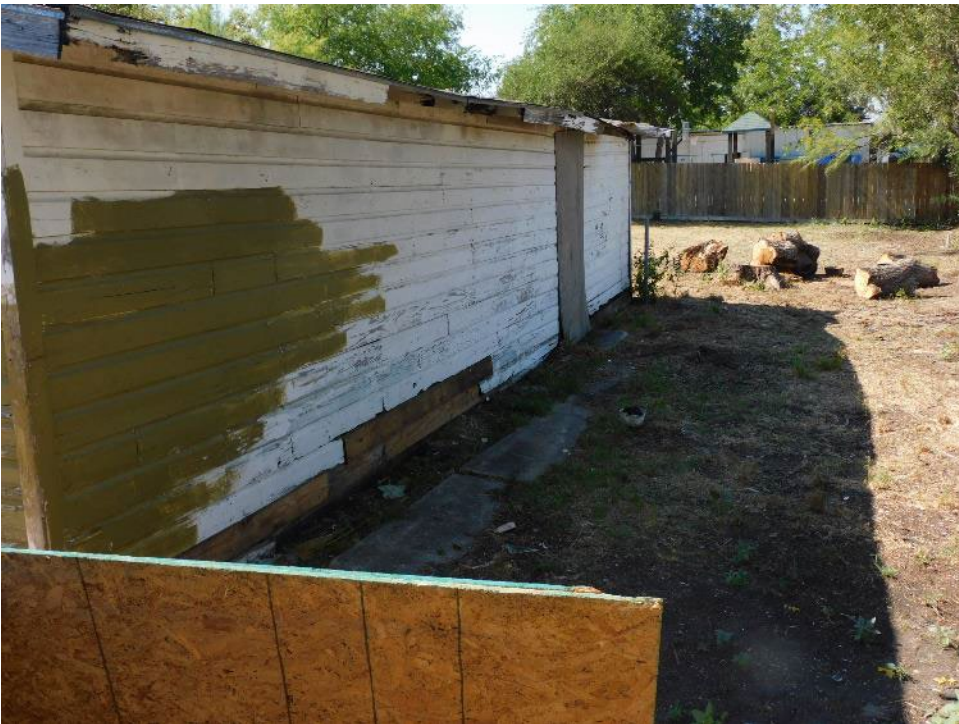
Photo 14, Exterior, garage cladding.

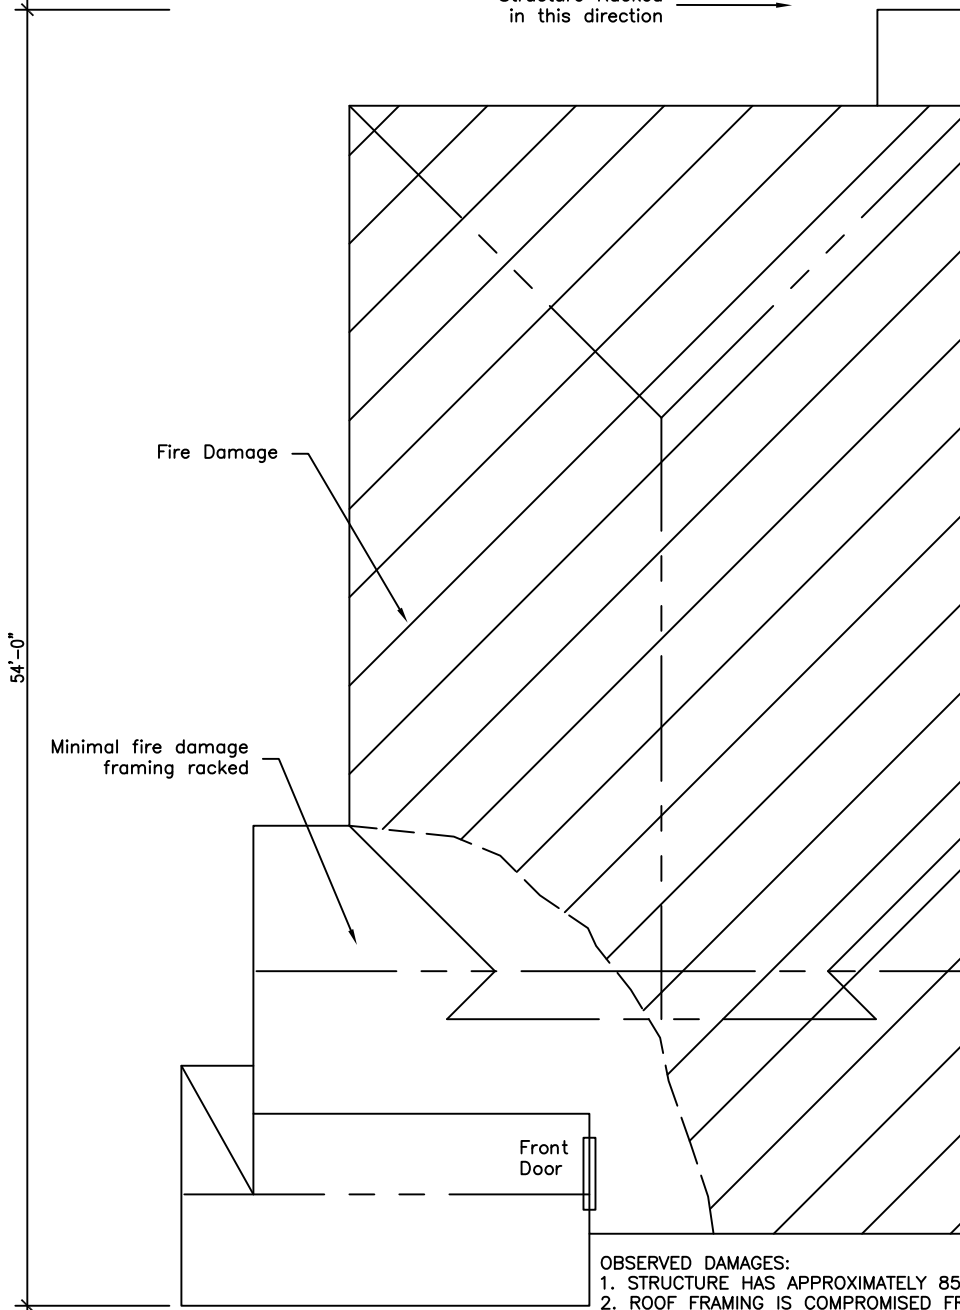
OVERALL DAMAGE

Structure Racked
in this direction →

1. STRUCTURE HAS APPROXIMATELY 85% FIRE DAMAGE.
2. ROOF FRAMING IS COMPROMISED FROM FIRE DAMAGE.
3. INTERIOR WALLS (LOAD BEARING & NON-LOAD BEARING) ARE COMPROMISED FROM FIRE DAMAGE.
4. REAR EXTERIOR WALL IS MISSING, ADJACENT WALLS ARE COMPROMISED.
5. FRAMING IS RACKED TO THE WEST.
6. STRUCTURE IS PARTIALLY SUPPORTED ON THE CEDAR POSTS.
7. CEDAR FOUNDATION POSTS ARE TOPPLED, TILTED, OR DISLODGED.
8. FOUNDATION WOOD BEAMS ARE DAMAGED.

1. DO NOT DEMOLISH BY HAND.
2. WALL FRAMING STRUCTURAL INTEGRITY IS COMPROMISED.
3. ROOF FRAMING STRUCTURAL INTEGRITY IS COMPROMISED.
4. PIER & WOOD BEAM FOUNDATION IS COMPROMISED.
5. DEMO ROOF AND WALLS VIA MECHANICAL METHODS.
6. DO NOT ENTER STRUCTURE, CRAWLSPACE, OR CLIMB ON ROOF.
