LEEDS BUILDING - 345 W. COMMERCE

HDCR EXHIBIT
FOR HDCR REVIEW AND REGULATORY APPROVAL ONLY, NOT FOR CONSTRUCTION

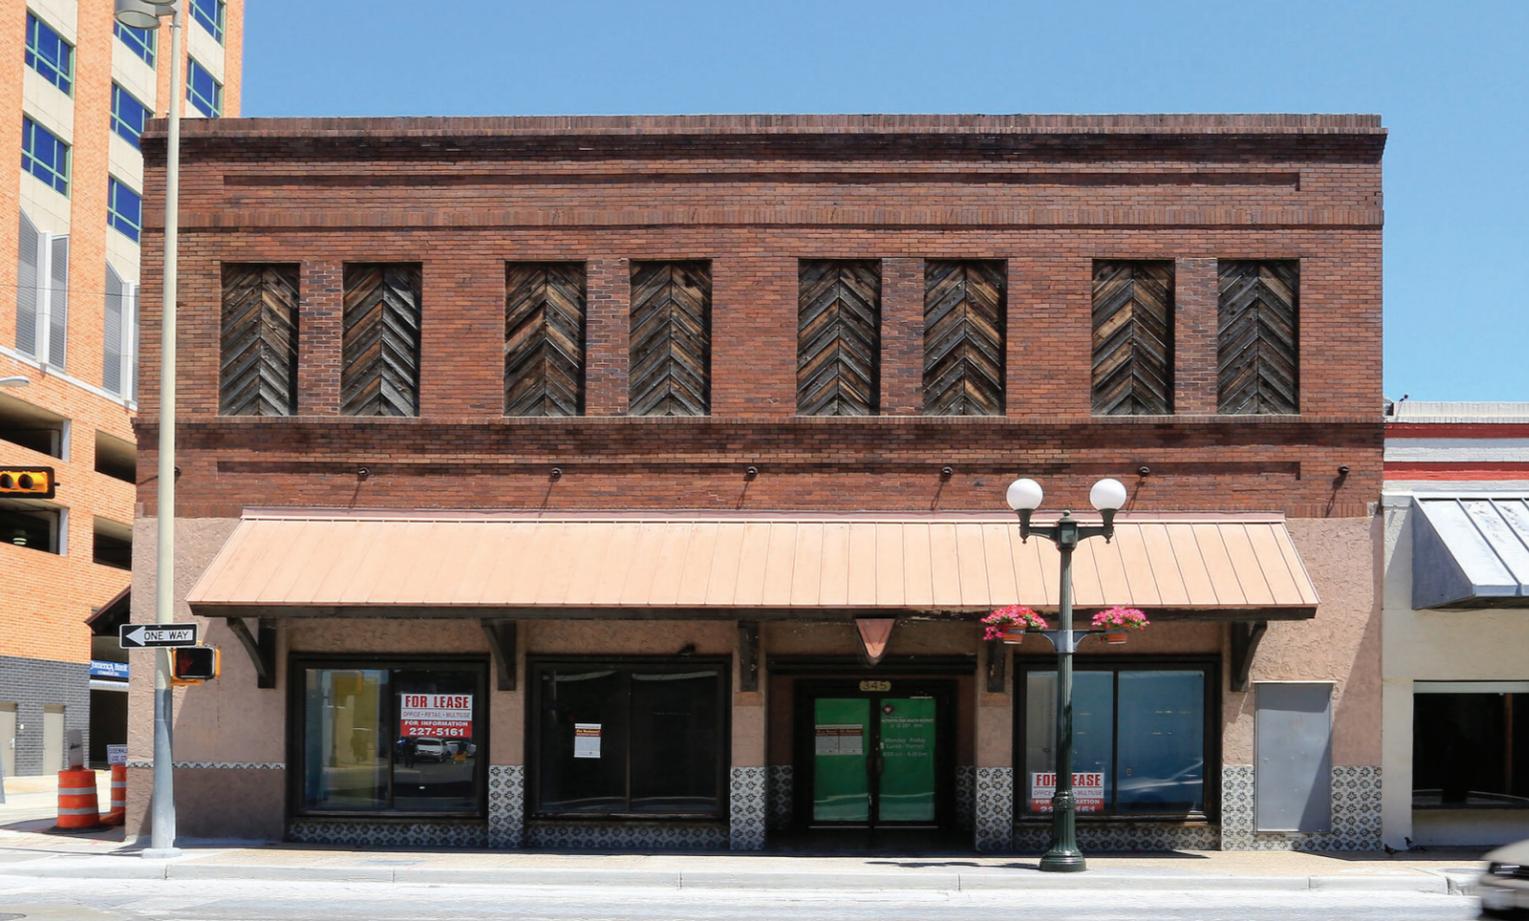
EXISTING CONDITIONS OBSERVED AT THE SOUTH FACADE SHOW BRICK MASONRY IN GOOD CONDITION. HISTORIC WINDOWS ON UPPER LEVEL ARE BOARDED UP WITH NON HISTORIC INFILL BRICK BETWEEN OPENINGS.

THE LOWER FACADE CONSISTS OF NON- HISTORIC ELEMENTS INCLUDING :

- WOOD AND METAL CANOPY
- ALUMINUM STOREFRONT
- TILE
- THICK TEXTURED STUCCO.

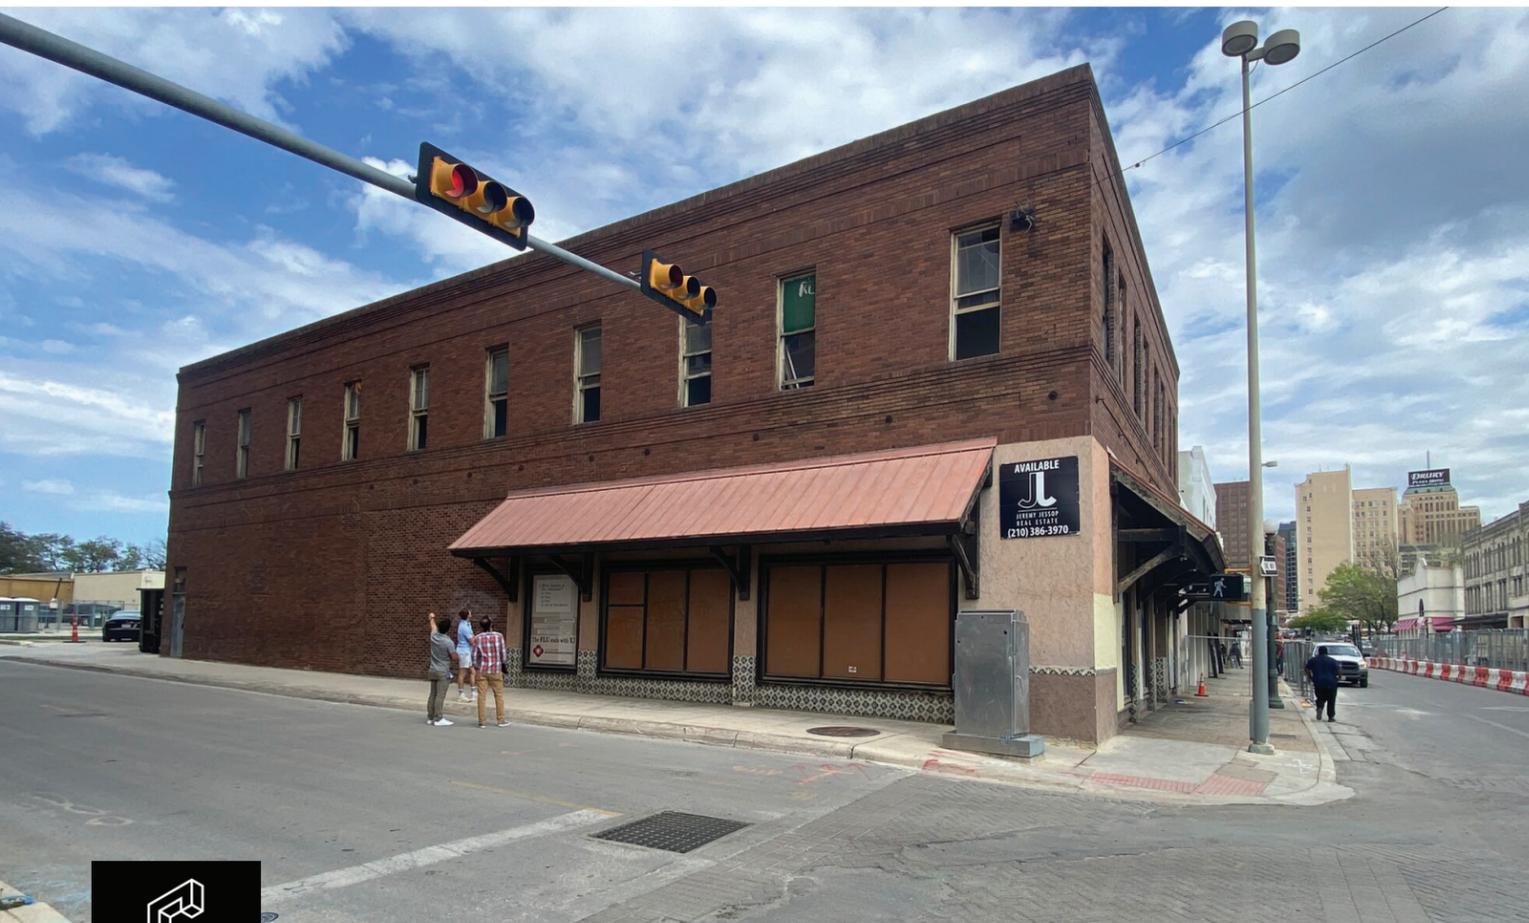
THE WEST FACADE TREATMENT IS SIMILAR TO THE SOUTH. EVIDENCE OF A LARGER STOREFRONT OPENING CAN BE SEEN WITH A DIS-SIMILAR BRICK INFILL LEFT OF THE EXISTING STOREFRONT.

EXISTING WINDOW ARE WOOD AND APPEAR TO BE THE ORIGINAL DOUBLE HUNG TYPE ON LEVEL 2.

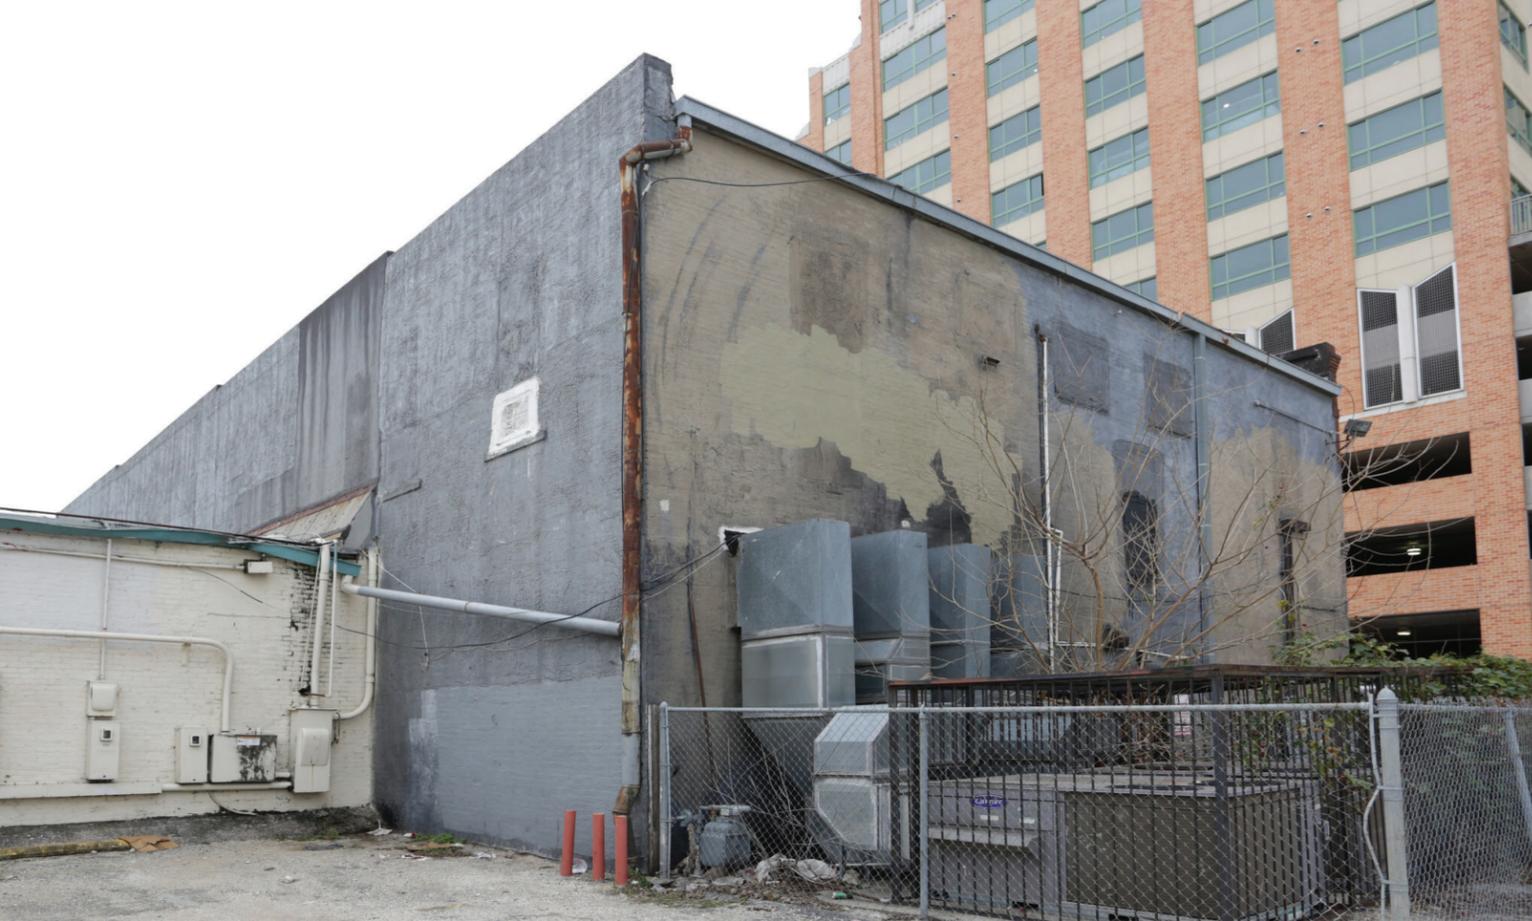
THE EAST FACADE ADJOINS THE NEIGHBORING BUILDING WITH THE BRICK FACADE PAINTED GRAY.

ORIGINAL WINDOWS OPENINGS ON THE UPPER LEVEL HAVE BEEN INFILLED .

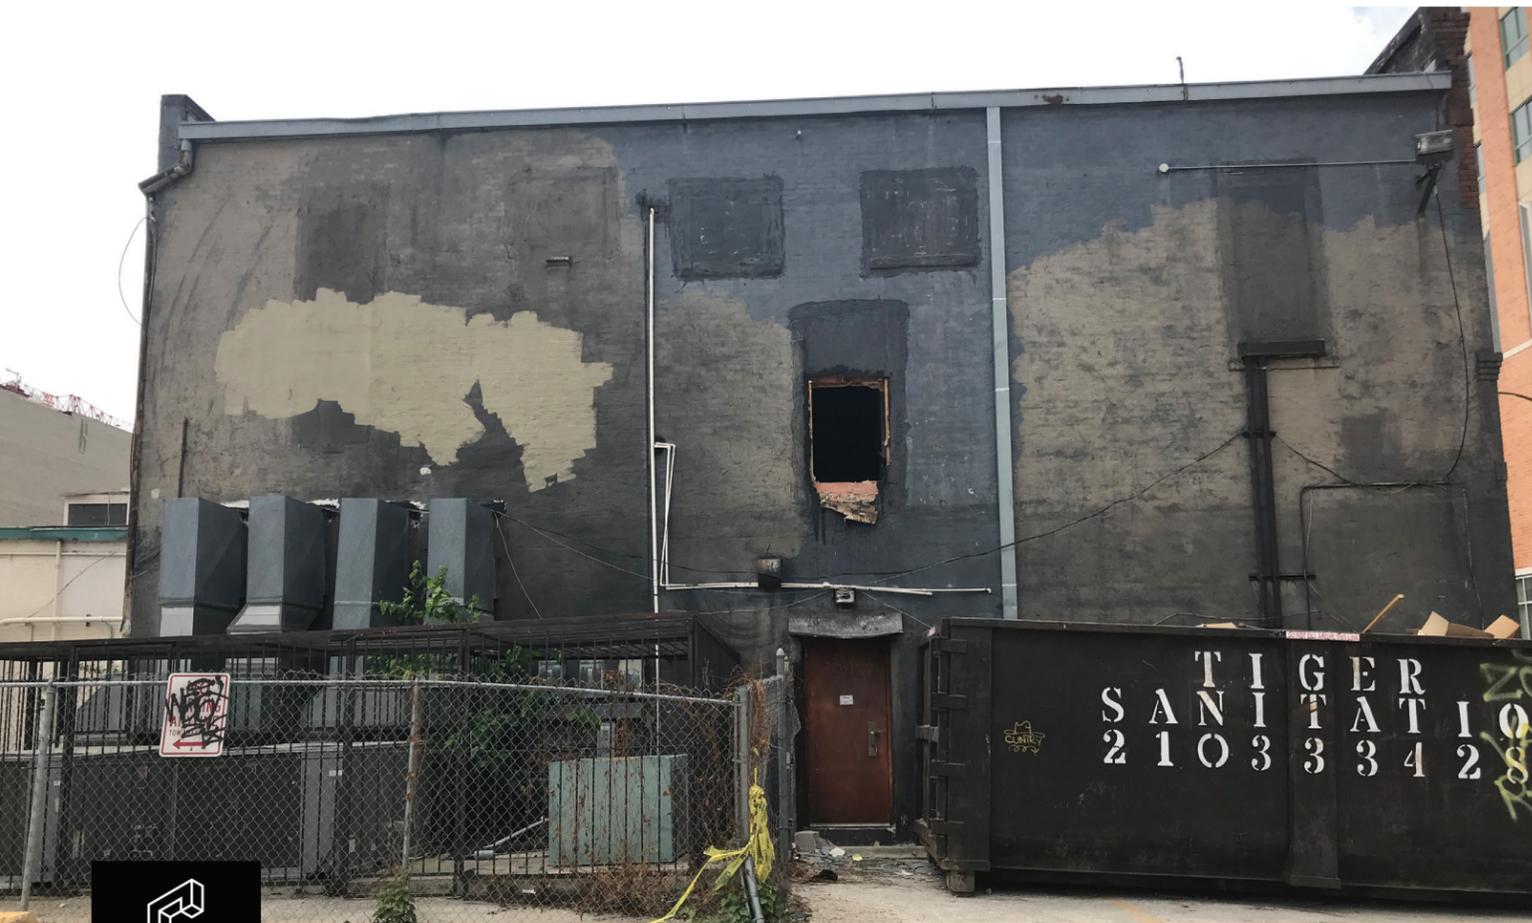
OBSERVED FROM HISTORIC PHOTOS IS EVIDENCE OF A LOWER SMALLER BUILDING ONCE ATTACHED TO THE NORTH FACADE.

THE ORIGINAL WINDOW OPENING ON THE UPPER LEVEL HAVE BEEN INFILLED AND THE BRICK MASONRY PAINTED GRAY.

THE CURRENT USE OF THIS AREA IS FOR A SERVICE ENTRANCE WITH A SMALL MECHANICAL YARD AND PARKING

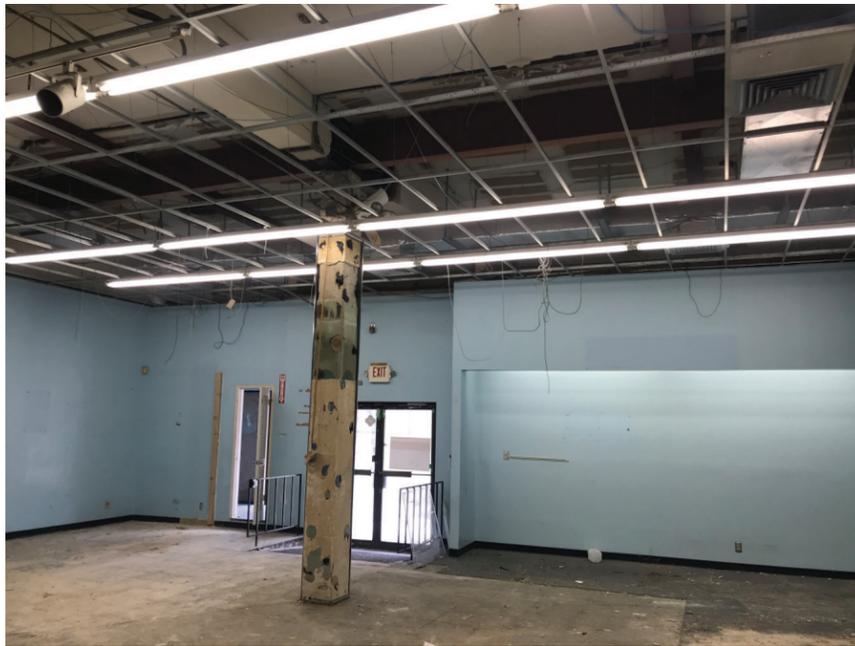
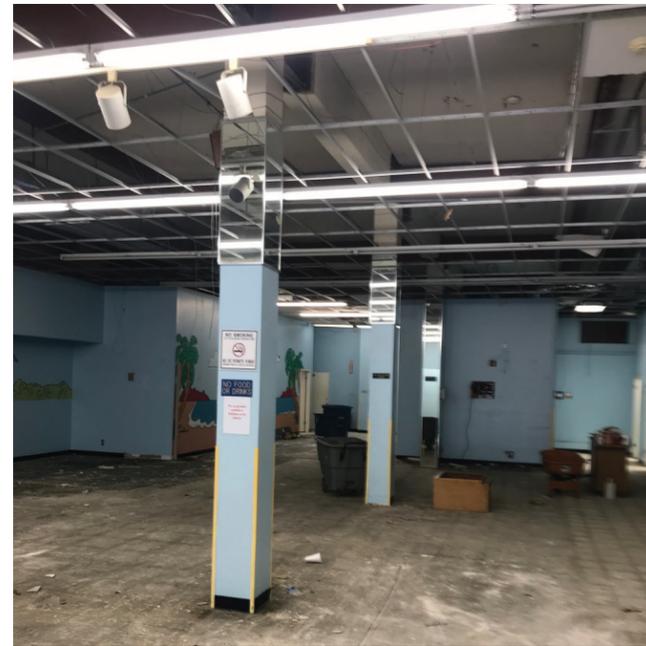
LEVEL 1 INTERIOR

CURRENT SHELL SPACE WITH EXISTING LAY IN CEILING GRID. EXTERIOR WALLS ARE INFILLED WITH DRYWALL PARTITIONS

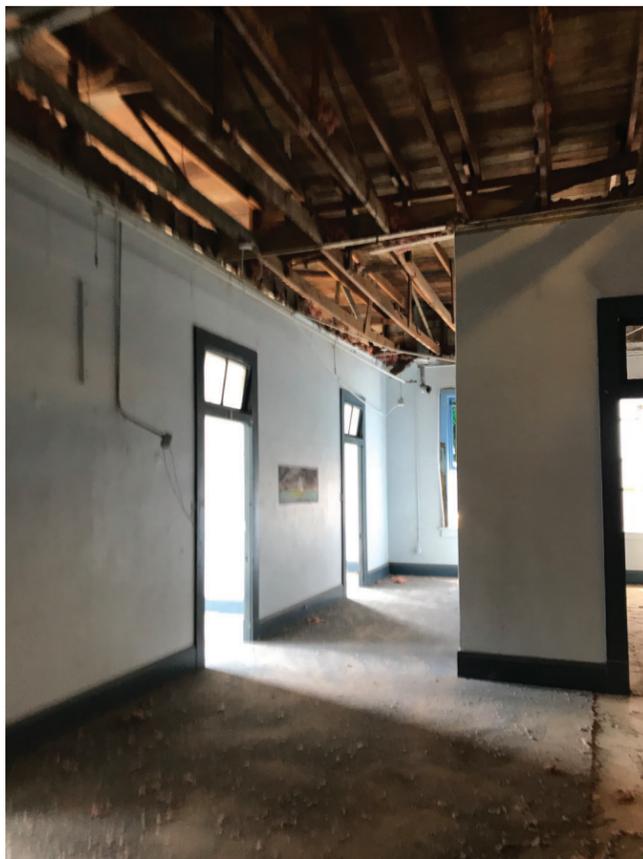
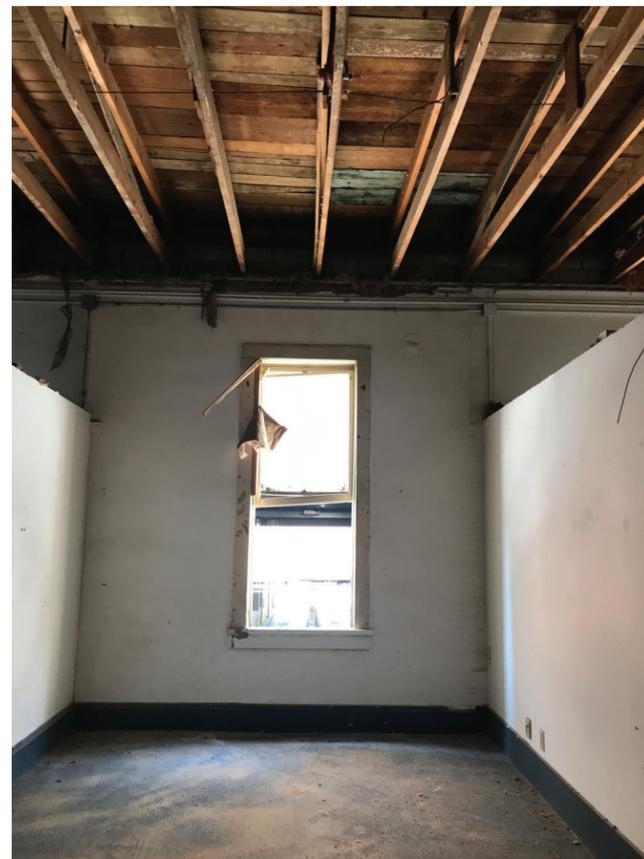
LEVEL 2 INTERIOR

OPEN CEILING WITH EXPOSED WOOD TRUSSES AND WOOD DECKING. THE CORRIDOR DOORWAYS WITH TRANSOMS ARE INTACT AND IN GOOD CONDITION.

WOOD WINDOW AT THE EXTERIOR ARE RETAINED AND IN NEED OF REPAIR.
