# HISTORIC AND DESIGN REVIEW COMMISSION

**HDRC CASE NO:** 2025-258  
**COMMON NAME:** Brackenridge Park  
**ADDRESS:** 3700 N ST MARYS ST  
**LEGAL DESCRIPTION:** NCB A49 PART OF A-2, A-4, A-52 (208 AC)  
**ZONING:** R-5  
**CITY COUNCIL DIST.:** 2  
**APPLICANT:** Ashton Williams/SWA  
**OWNER:** Jamaal Moreno/CITY OF SAN ANTONIO  
**TYPE OF WORK:** Park improvements to Pump House, Water Works Raceway, Upper Labor Acequia, Lily Pond, Diversion Dam, and Restroom Pavilions  
**APPLICATION RECEIVED:** September 26, 2025  
**60-DAY REVIEW:** November 25, 2026 (Review period waived)  
**CASE MANAGER:** Edward Hall

The applicant is requesting a Certificate of Appropriateness for park improvements related to Phase 2 of the Brackenridge Park bond projects. The Phase 2 scope of work includes:

PHASE 2 HDRC MEETING  
21 JANUARY 2026

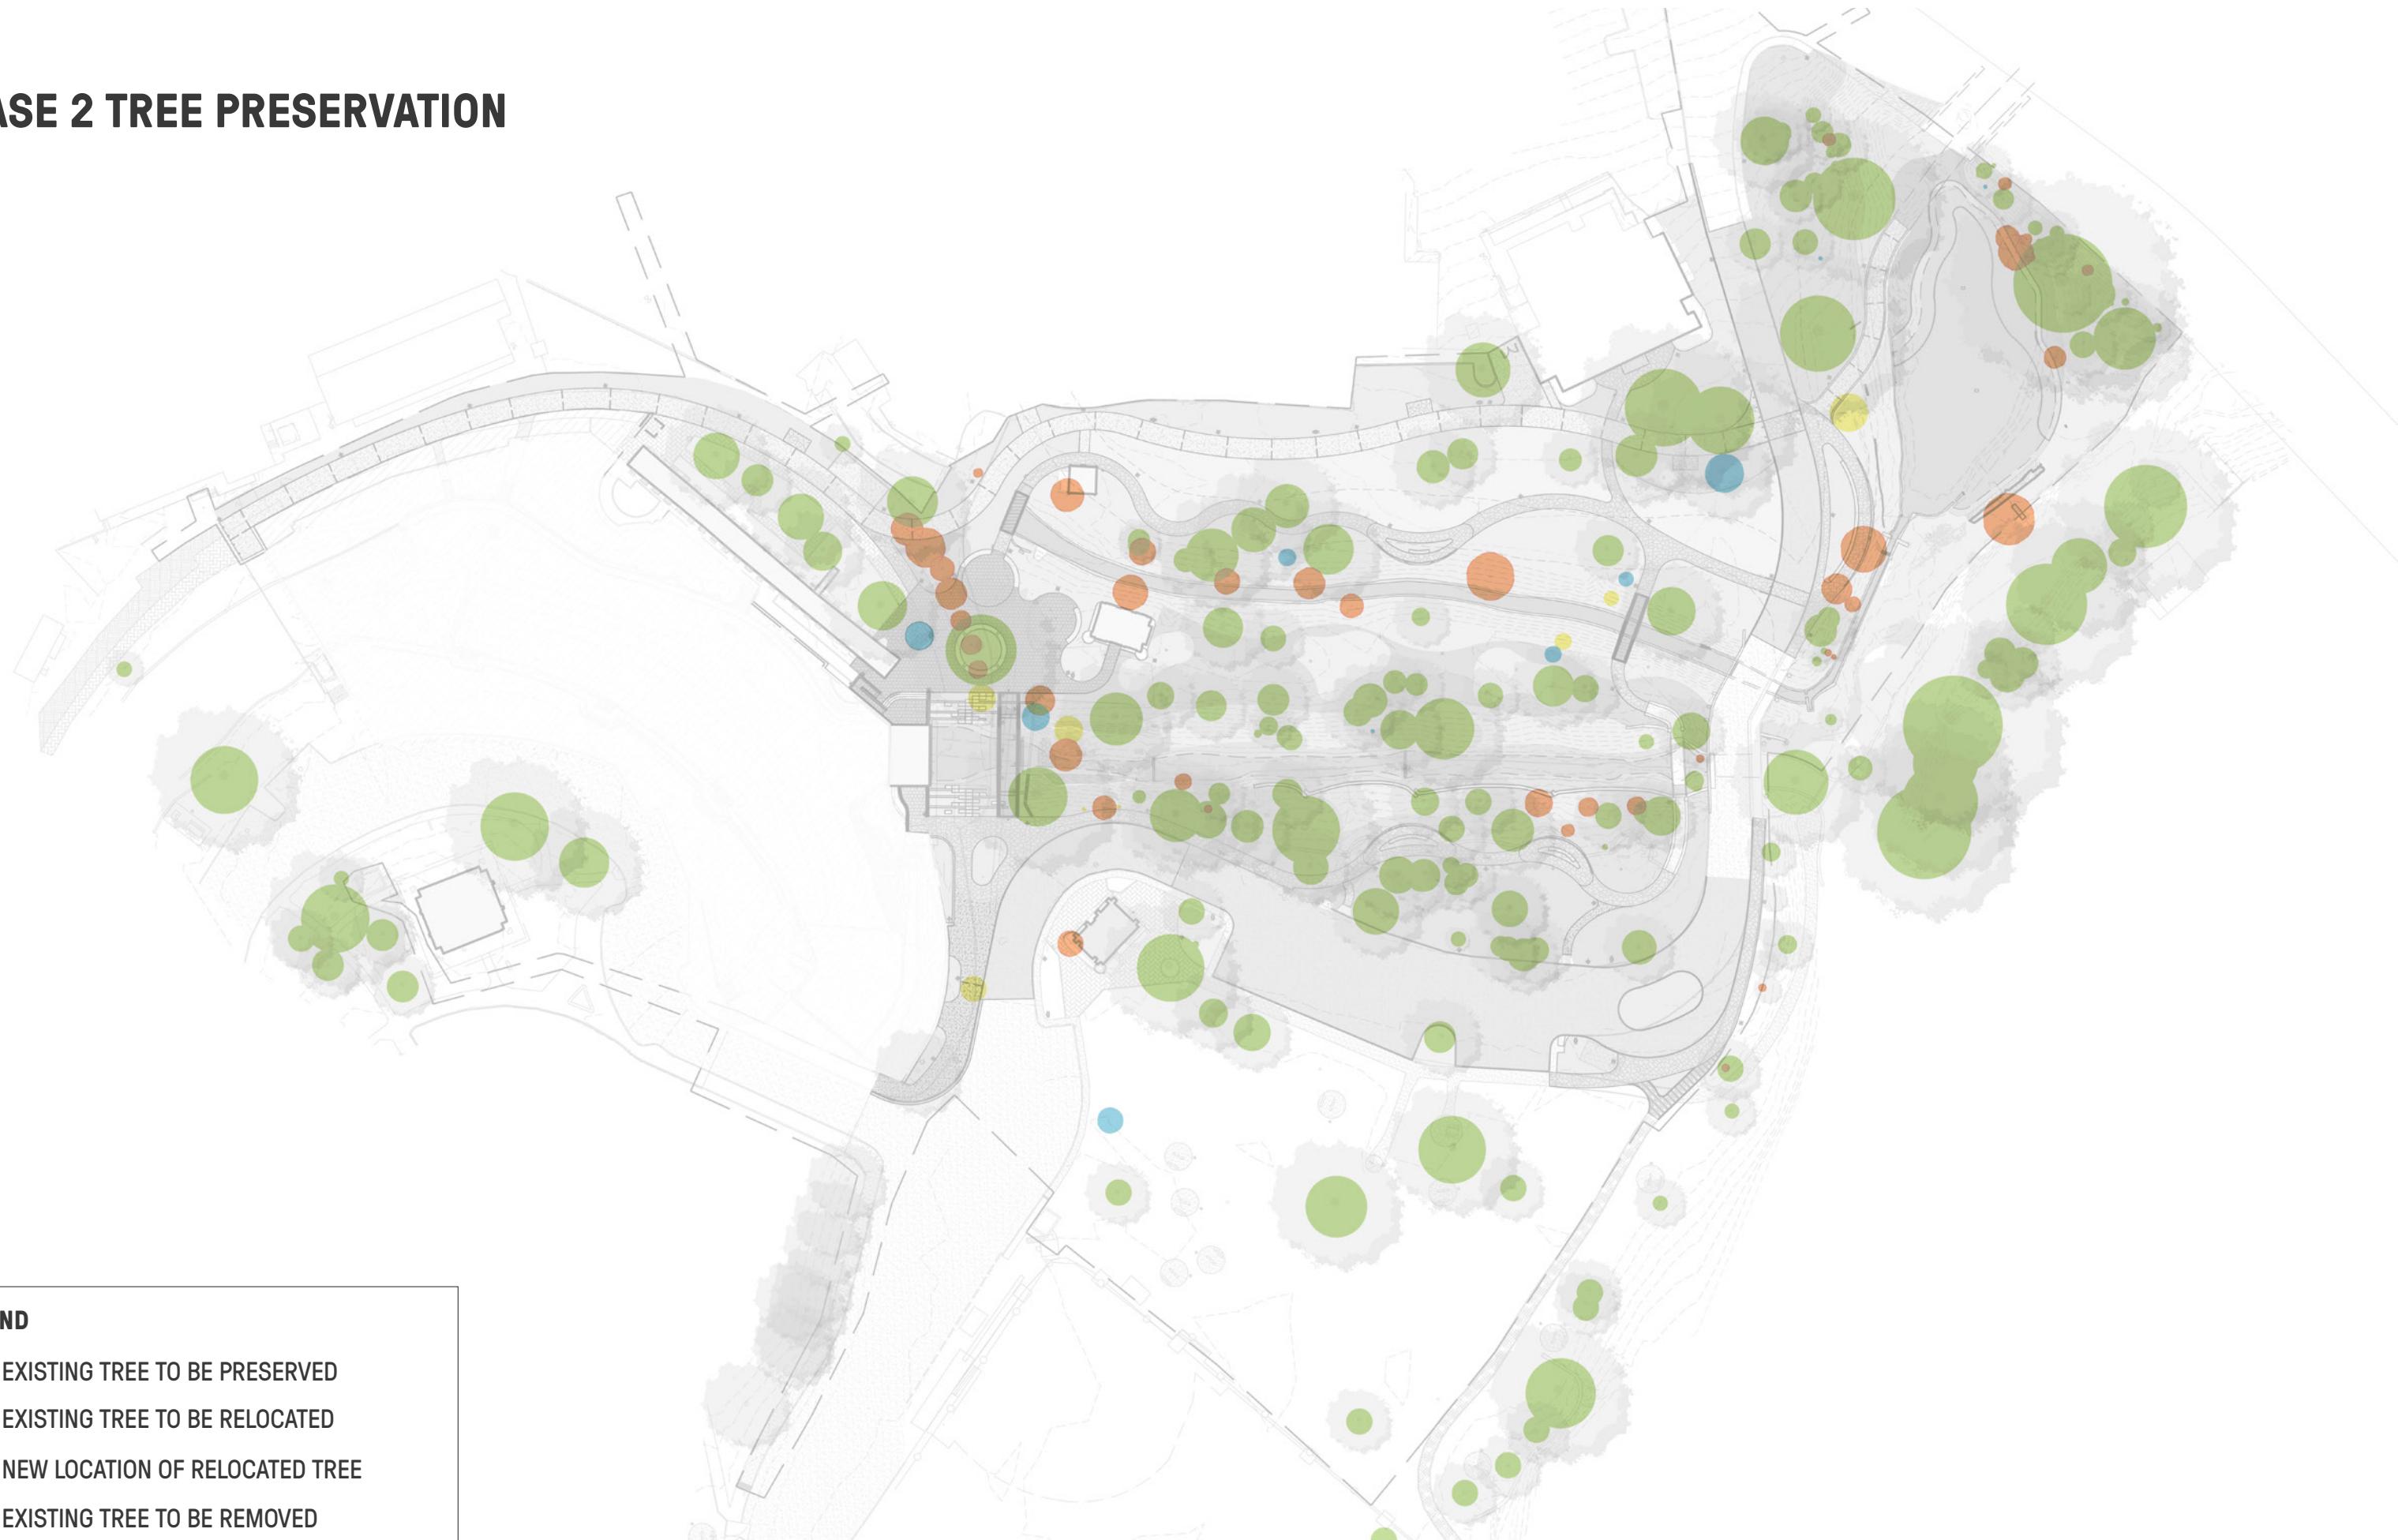
## PHASE 2 TREE PRESERVATION

\*TOTAL NUMBER OF TREES HAVE BEEN MODIFIED TO INCLUDE EXPANDED PROJECT SCOPE FOR UTILITY MODIFICATIONS. TREES ON PLAN LOCATED OUTSIDE PROJECT BOUNDARY HAVE BEEN EXCLUDED FROM PHASE II TREE TOTALS.

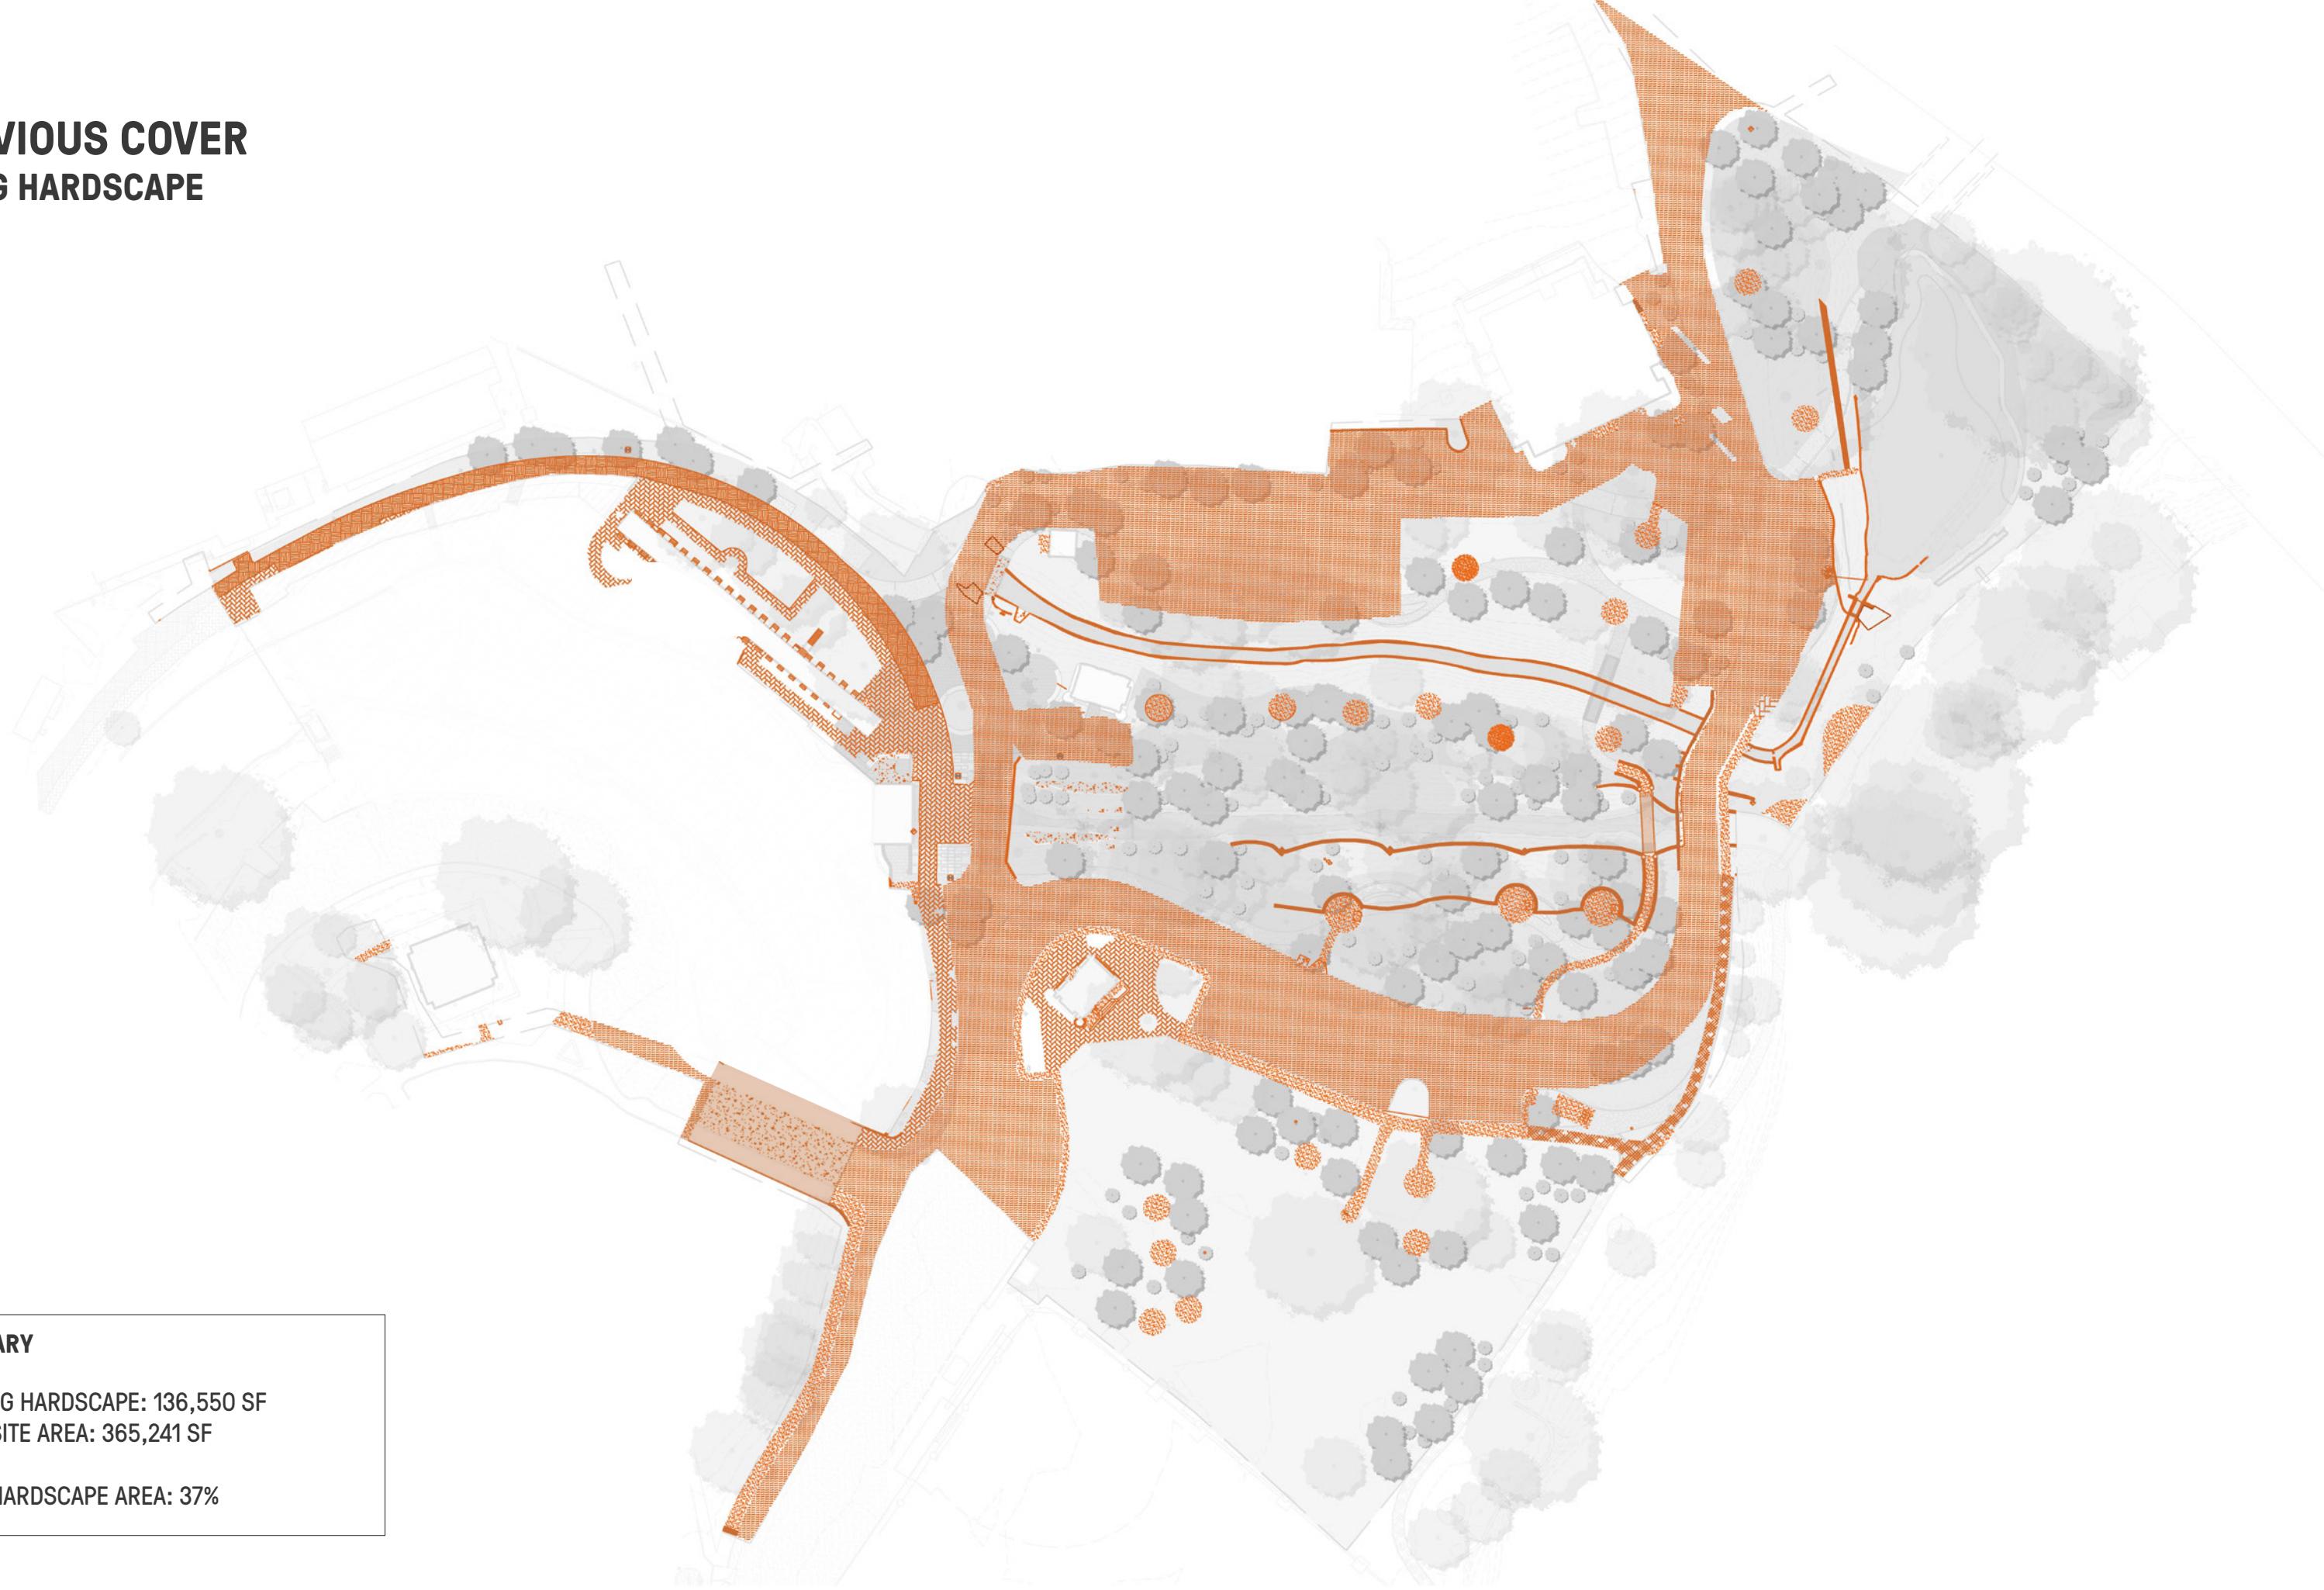
## IMPERVIOUS COVER EXISTING Hardscape

EXISTING Hardscape: 136,550 SF  
TOTAL SITE AREA: 365,241 SF

TOTAL Hardscape AREA: 37%

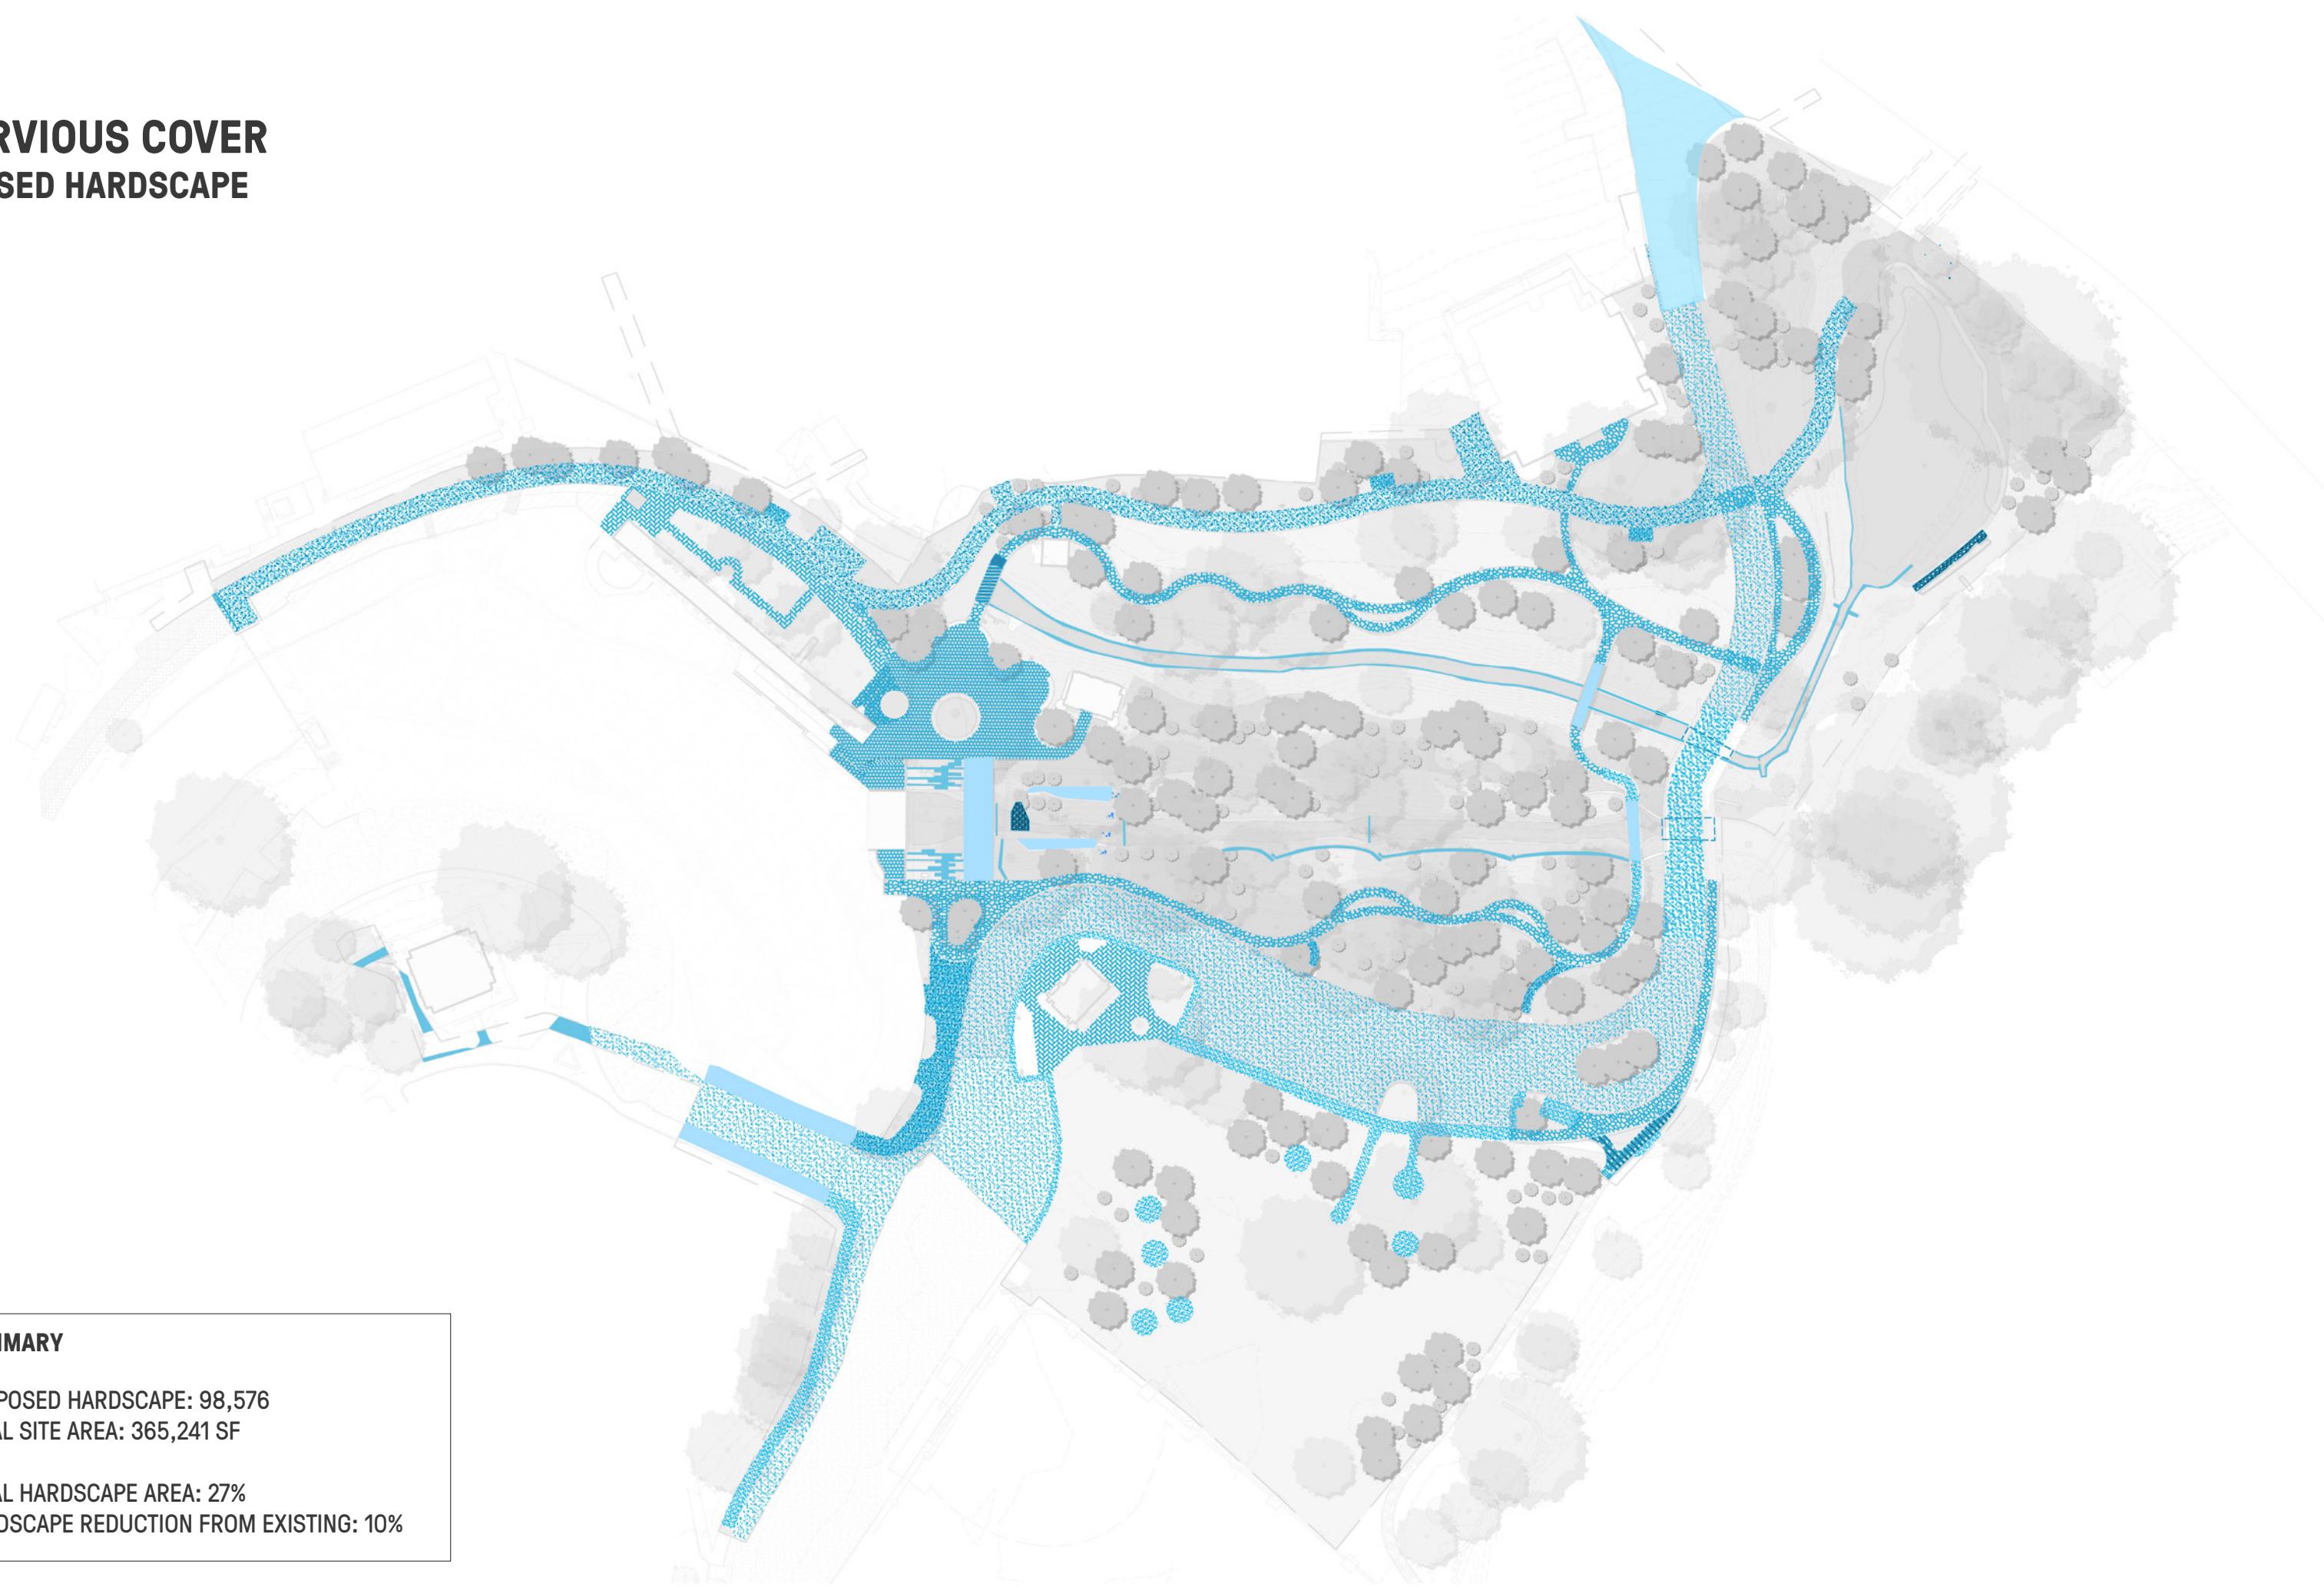
## IMPERVIOUS COVER PROPOSED Hardscape

PROPOSED Hardscape: 98,576  
TOTAL SITE AREA: 365,241 SF

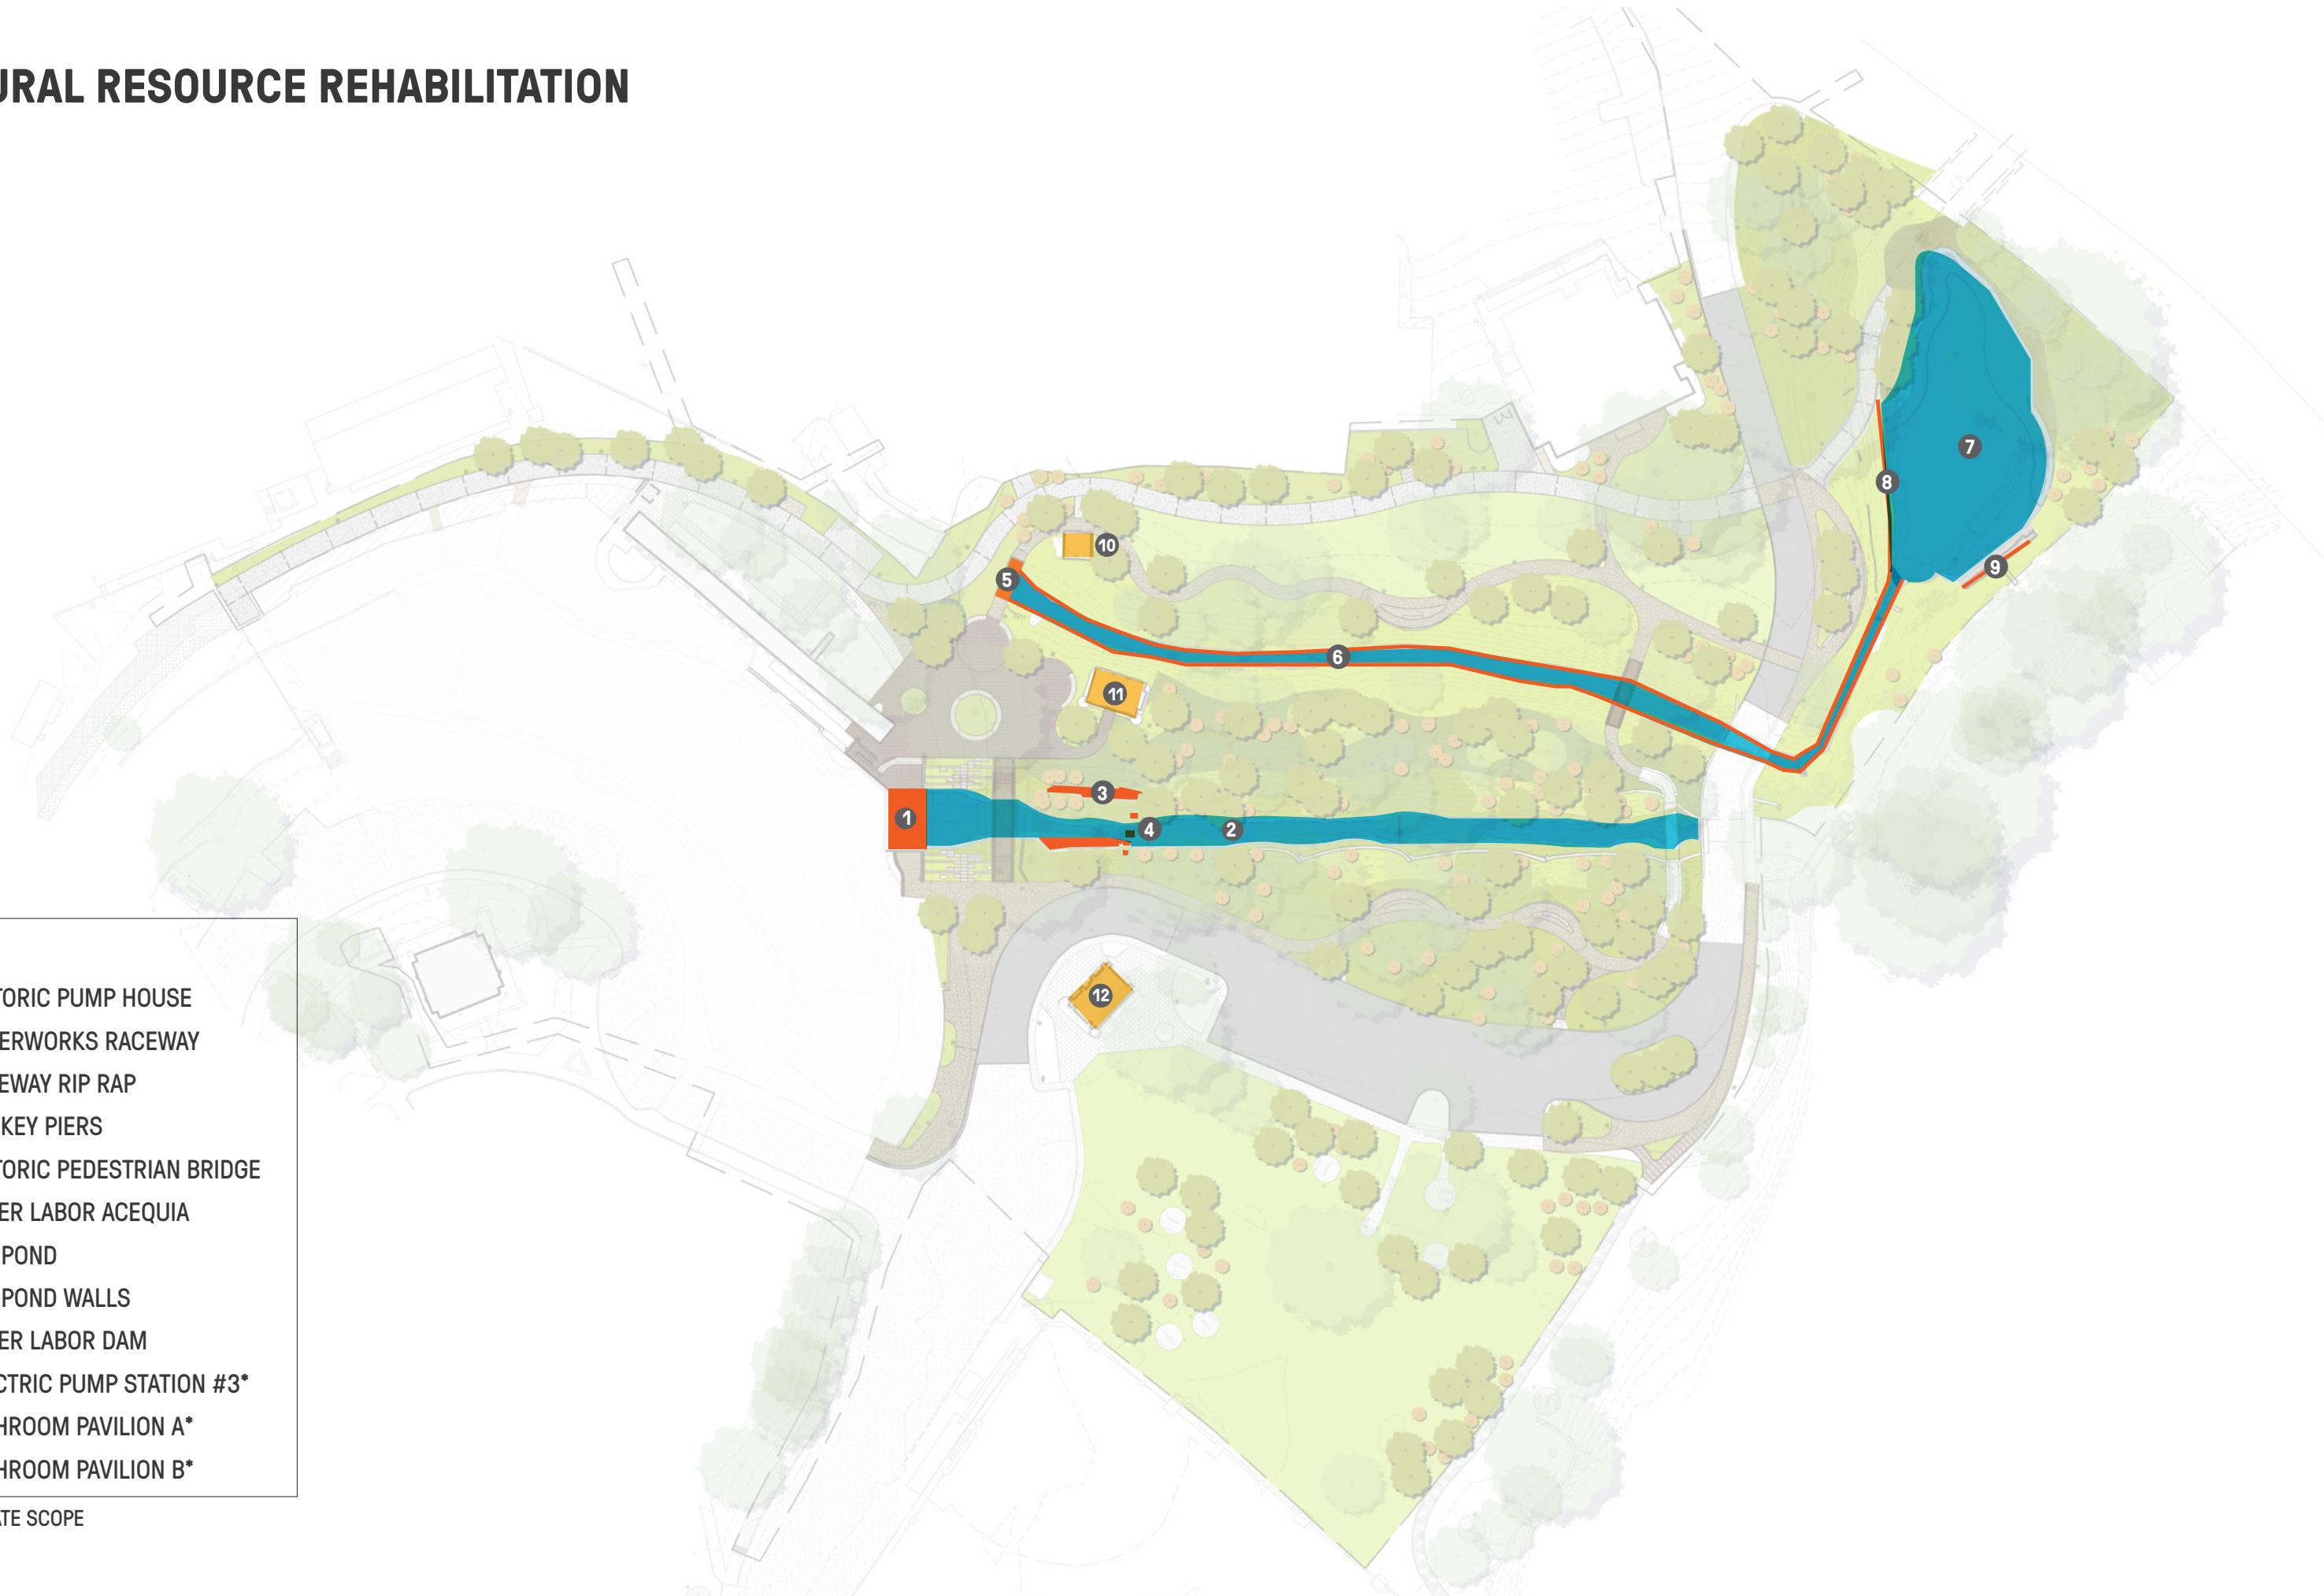
LEGEND	
①	HISTORIC PUMP HOUSE
②	WATERWORKS RACEWAY
③	RACEWAY RIP RAP
④	DONKEY PIERS
⑤	HISTORIC PEDESTRIAN BRIDGE
⑥	UPPER LABOR ACEQUIA
⑦	LILY POND
⑧	LILY POND WALLS
⑨	UPPER LABOR DAM
⑩	ELECTRIC PUMP STATION #3*
⑪	BATHROOM PAVILION A*
⑫	BATHROOM PAVILION B*

\*ADD ALTERNATE SCOPE

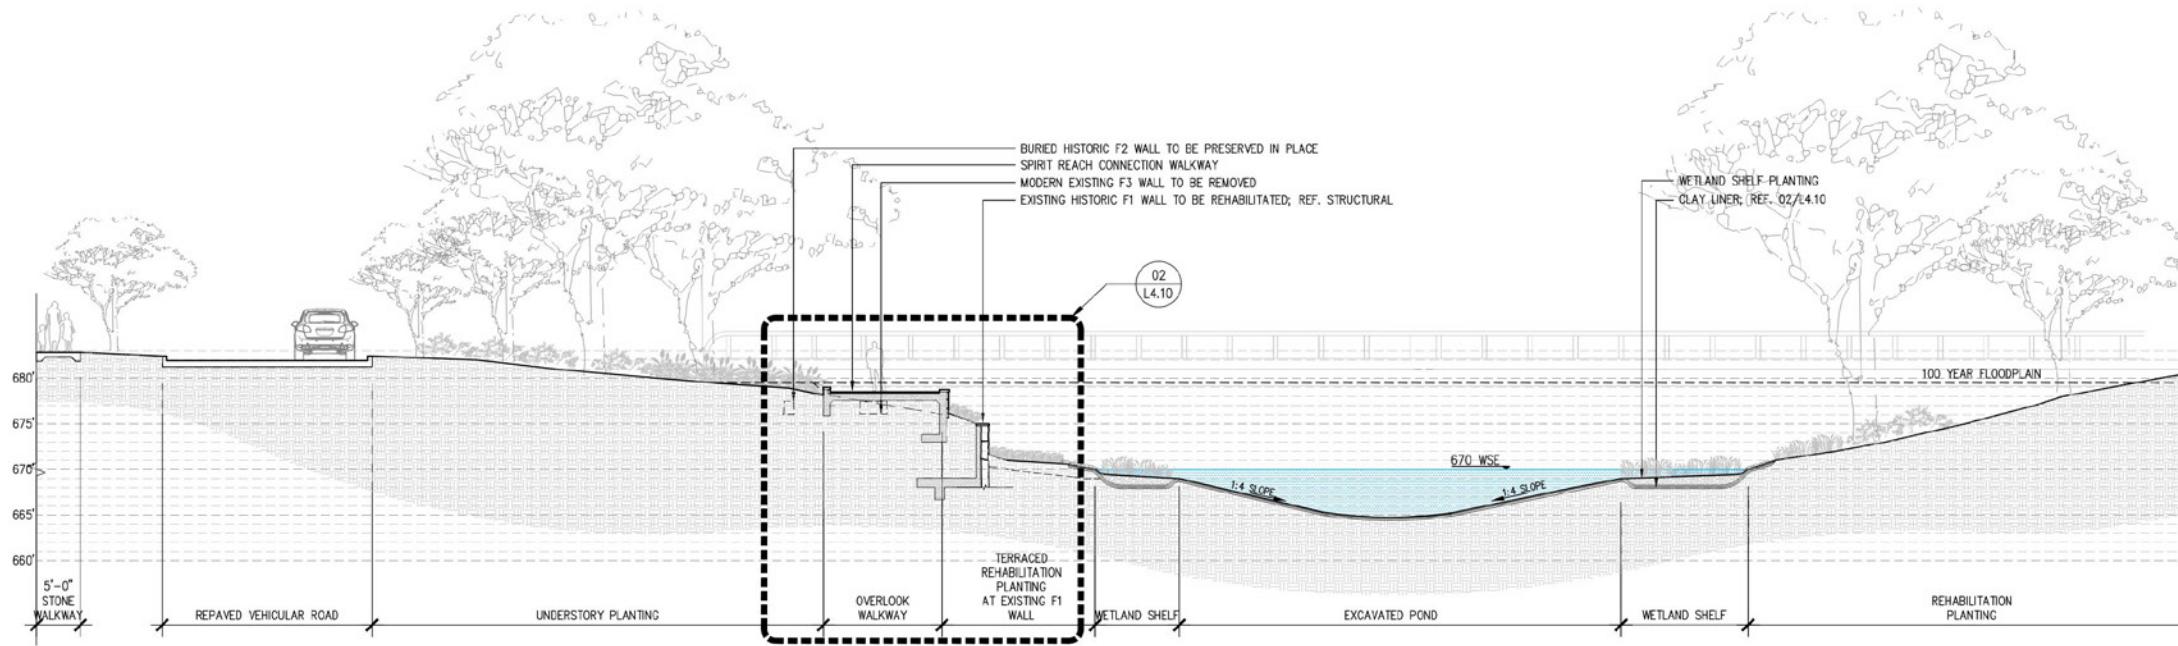
02 SECTION – LILY POND AT SPIRIT REACH WALKWAY  
1/8" = 1'-0"

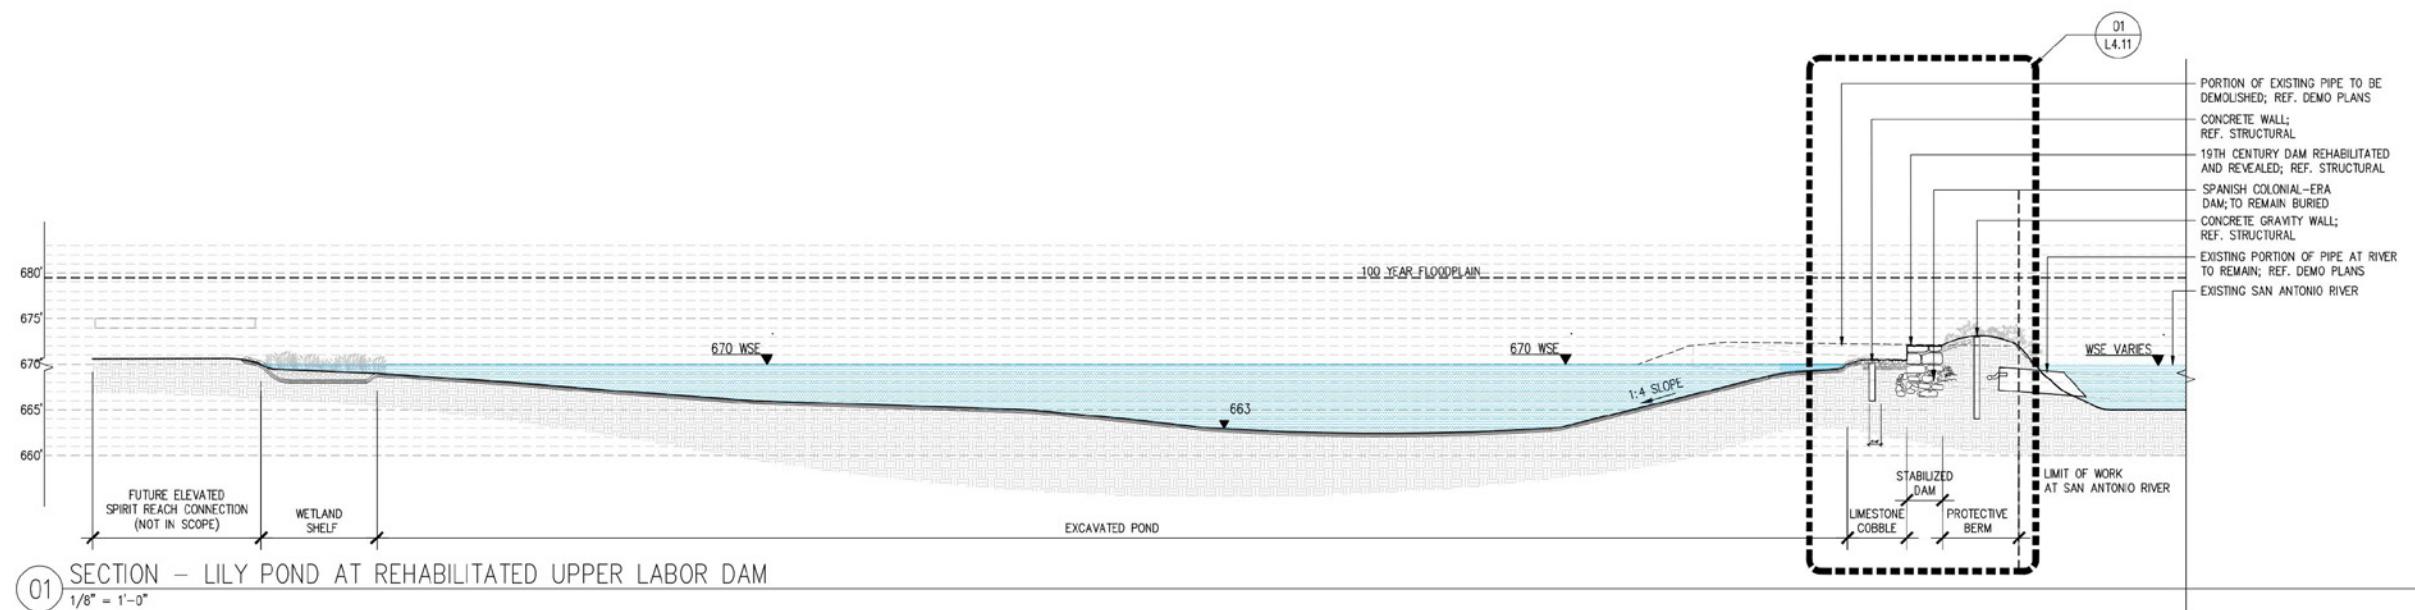
01 SECTION – LILY POND AT REHABILITATED UPPER LABOR DAM  
1/8" = 1'-0"

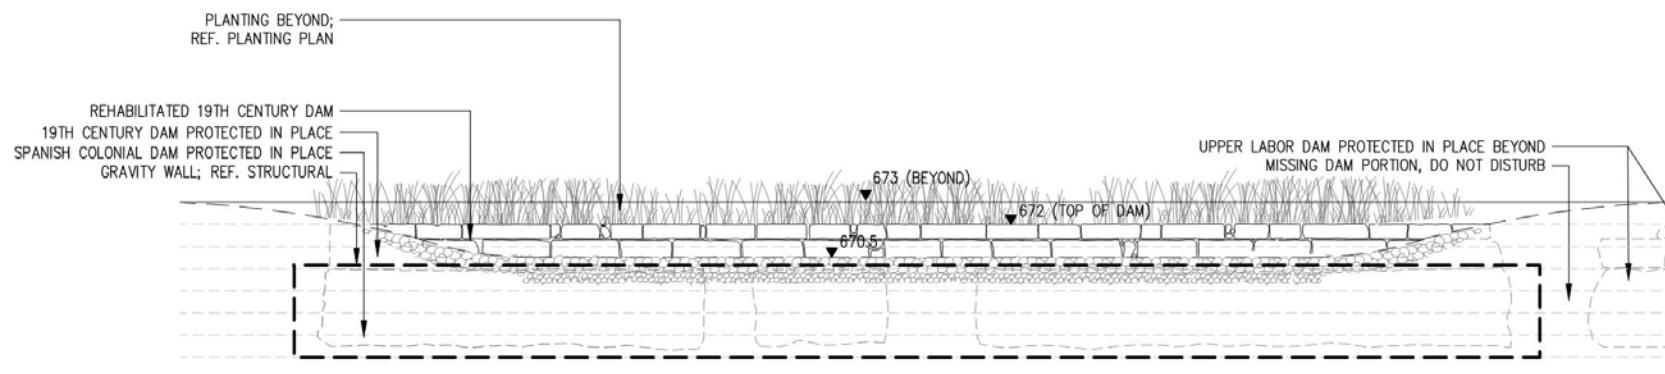
03 UPPER LABOR DAM SECTION  
1/4" = 1'-0"

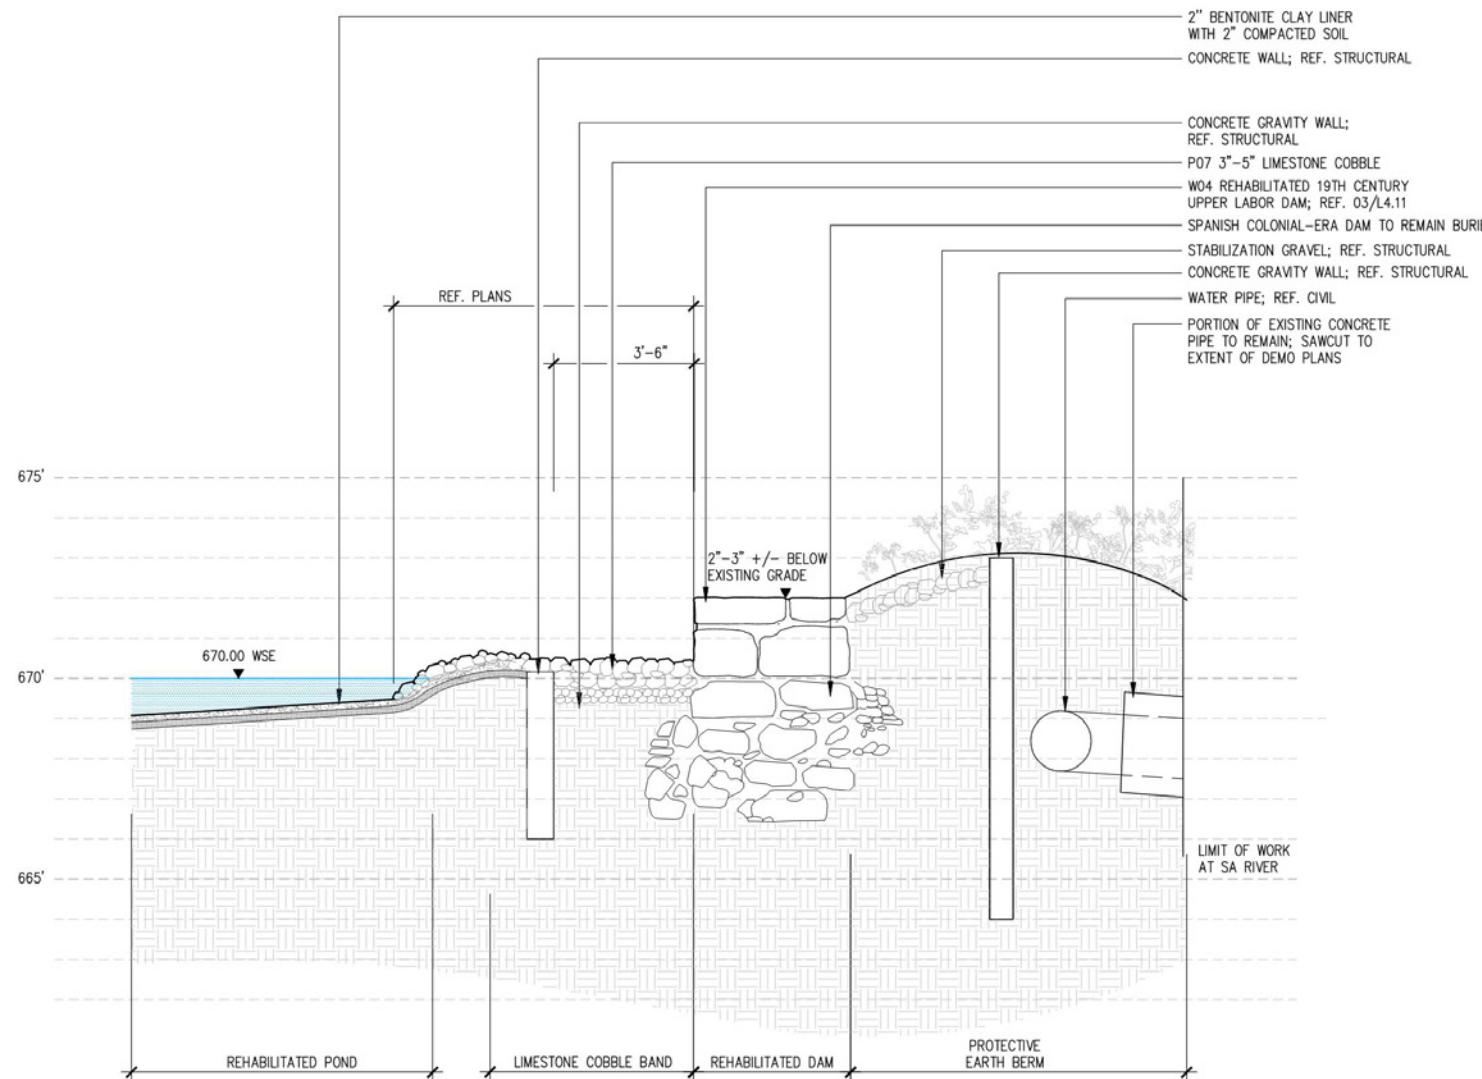
01 SECTION – REHABILITATED UPPER LABOR DAM  
1/2" = 1'-0"

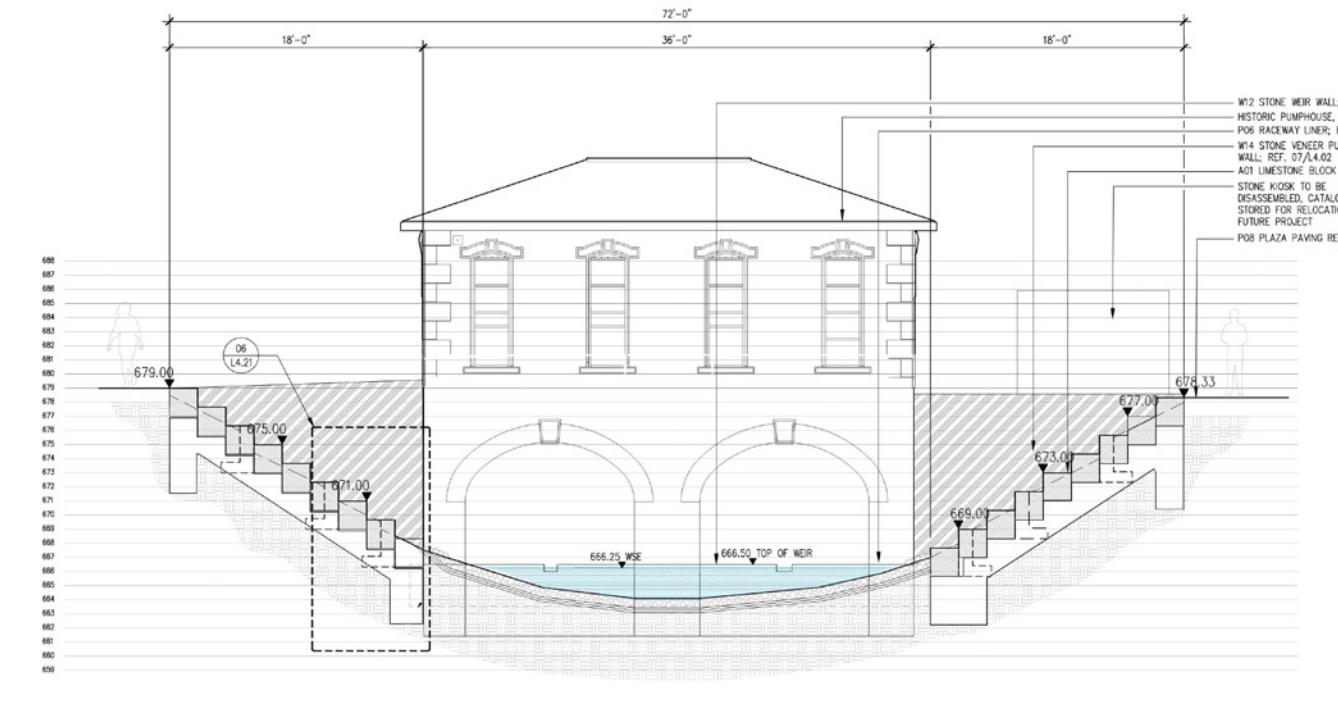
02 SECTION - SEATING TERRACES AT PUMP HOUSE

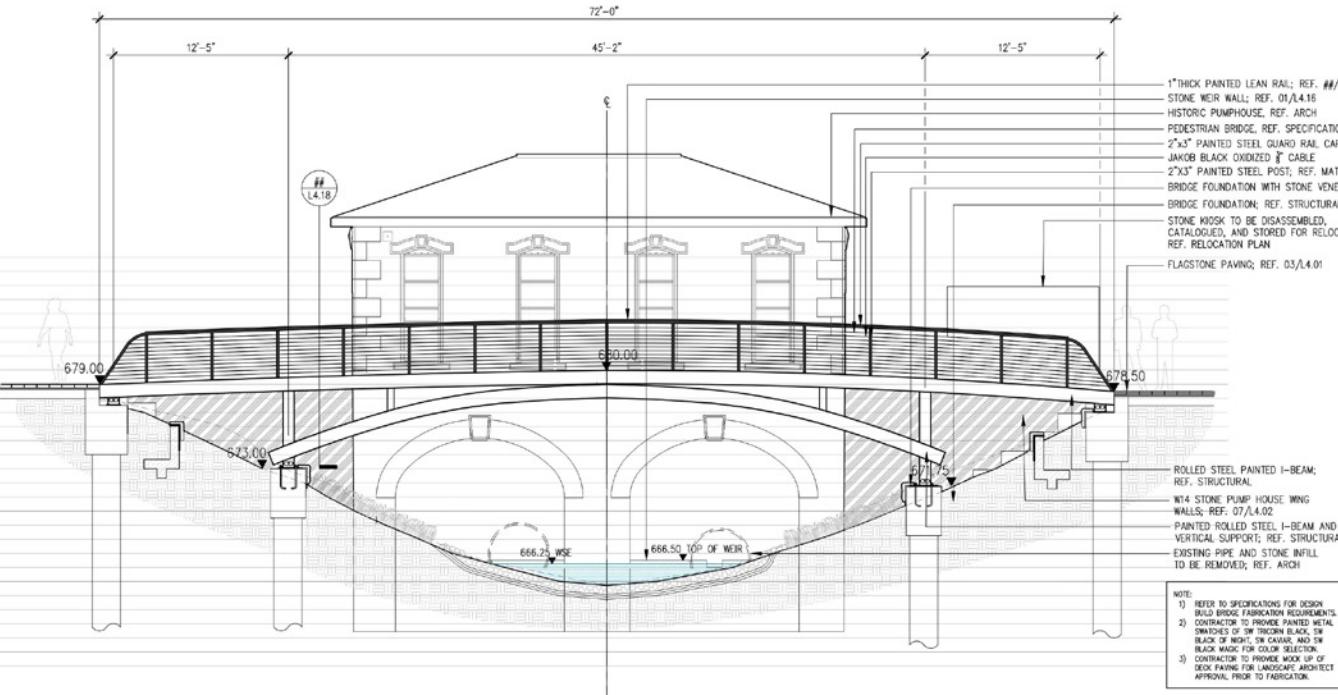
02 SECTION ELEVATION - STEEL INVERTED ARCH PEDESTRIAN BRIDGE AT PUMP HOUSE
