## 206 Lavaca Street

Historical Design Review Committee  
Application for Conceptual Approval

cotton estes architect

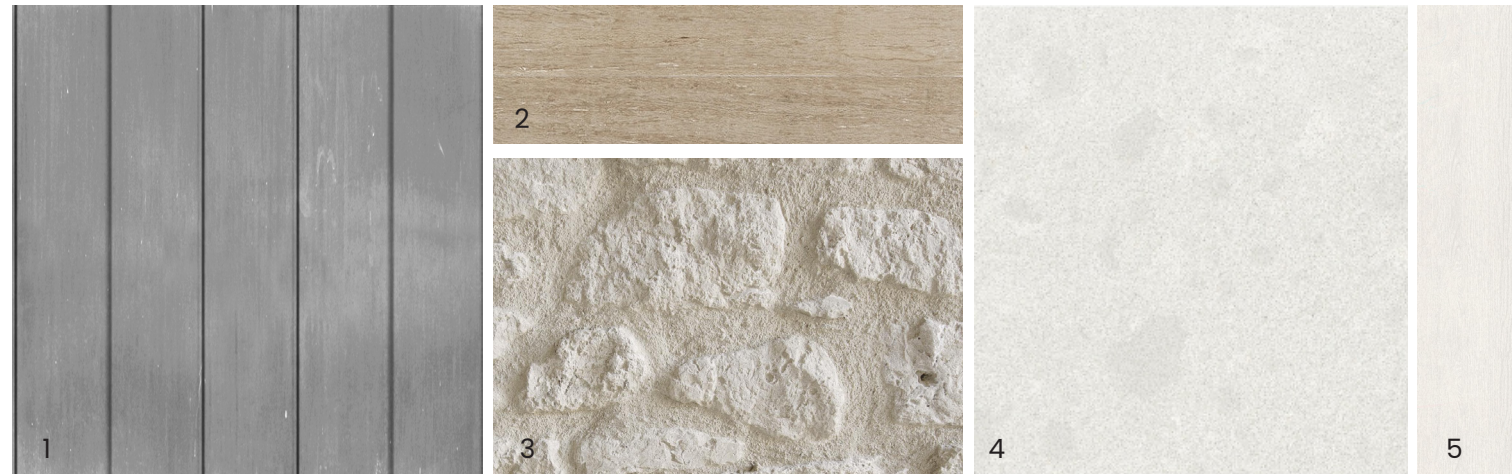
We propose to replace the existing, damages standing seam metal roof with a new, in-kind standing seam metal roof. Roof panels will be 18 to 21 inches in width, seams will be 1 1/2" in height with a hand-crimped ridge. The proposed roof will be galvanized or bonderized metal, which will quickly patina to grey.

Thermally-modified ash is proposed for the porch framing. The heat-treatment process alters the wood's cellular structure, increasing dimensional stability and decay resistance without chemical preservatives, making it well suited to South Texas's climate. Its warm, tight grain offers a natural material palette in keeping with the home's historic character. Framing and deck details will be in accordance with OHP Design Guidelines.

Hydraulic lime plaster is proposed for all exterior caliche walls where exposed to the elements. Unlike modern elastomeric products, traditional hydraulic lime plaster allows the caliche to breathe and shed moisture rather than trapping it which helps to extend the life of the original structure.

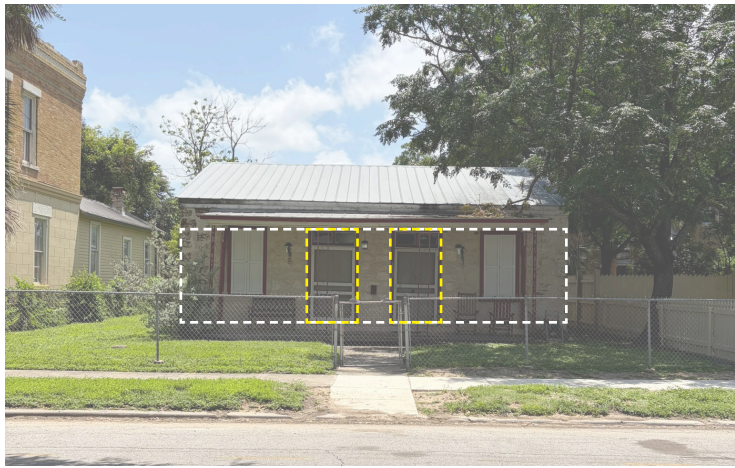
130 Lavaca  
34'-0" wide facade  
(2) 4'-0" wide doors  
23.5%

A survey of 8 contributing structures per the National Register of Historic Places nomination yielded a median entry-to-facade ratio of 19.1% and a mean of 19.5%.

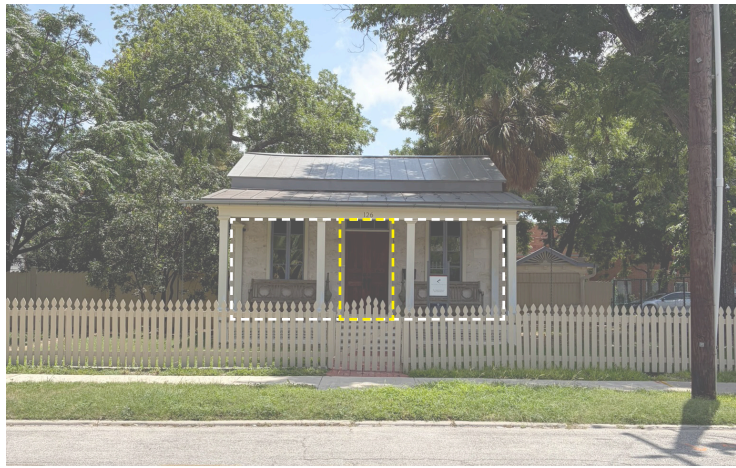
126 Lavaca  
21'-0" wide facade  
5'-0" wide door  
23.8%

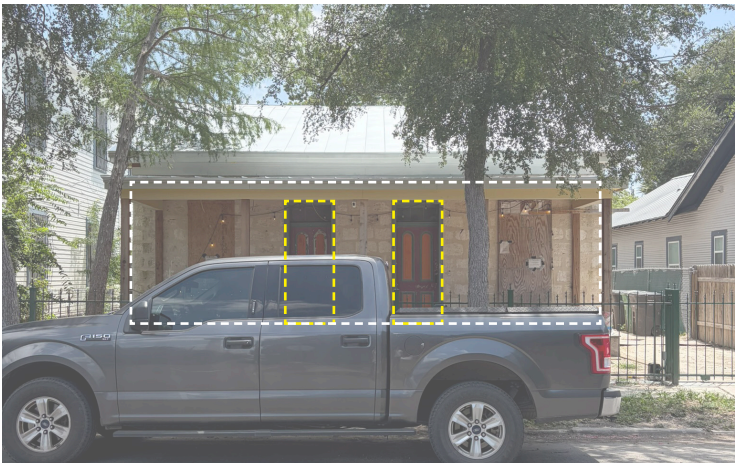
116 Camargo  
36'-0" wide facade  
(2) 3'-6" wide doors  
19.4%

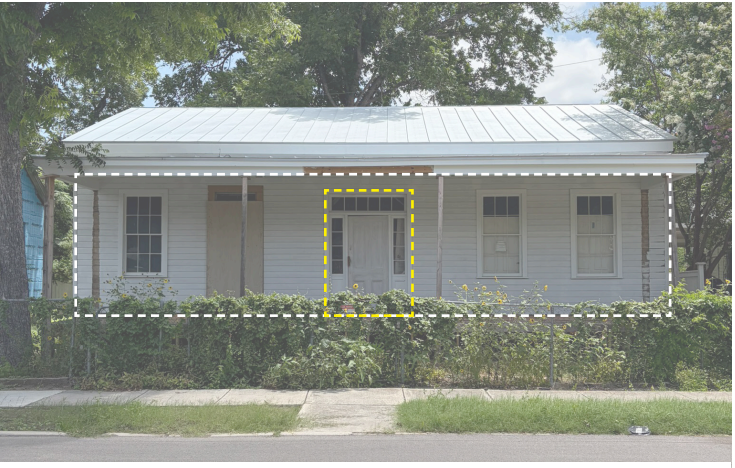
126 Camargo  
44'-0" wide facade  
6'-0" wide door + sidelites  
13.6%

## ENTRY-TO-FACADE RATIOS:

| Surveyed Contributing Homes: | 19.1 – 19.5% |

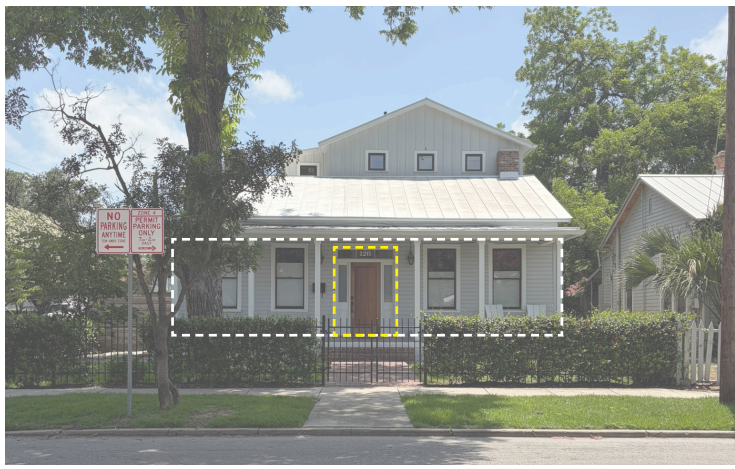
126 Barrera  
21'-0" wide facade  
5'-0" wide door + sidelites  
16.7%

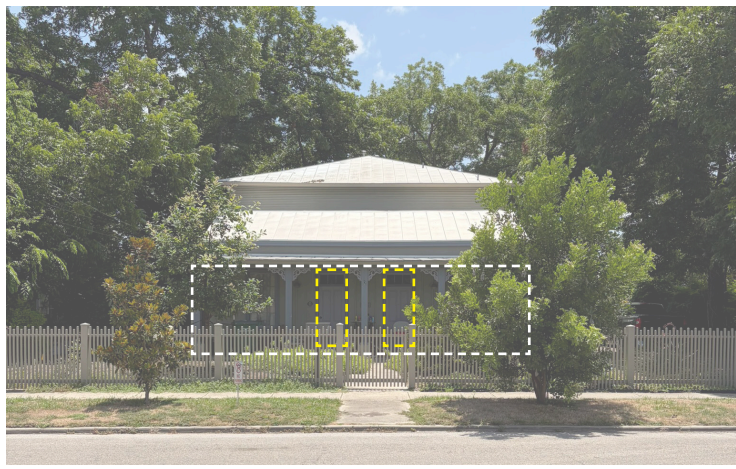
118 Barrera  
33'-0" wide facade  
(2) 3'-6" wide doors  
21.2%

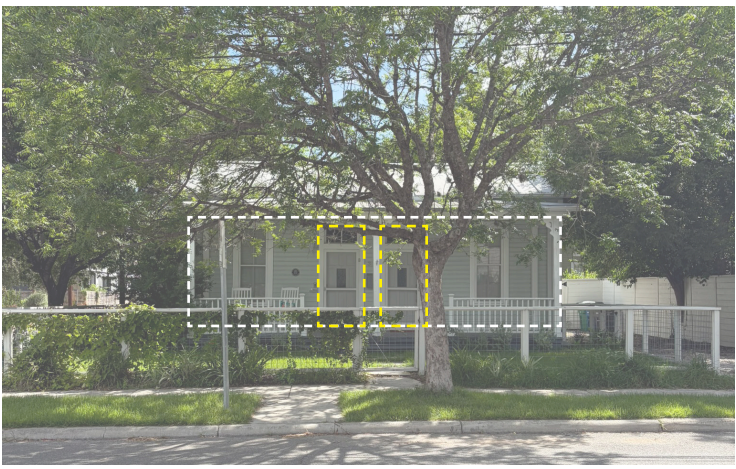
301 Barrera  
32'-0" wide facade  
(2) 3'-0" wide doors  
18.8%

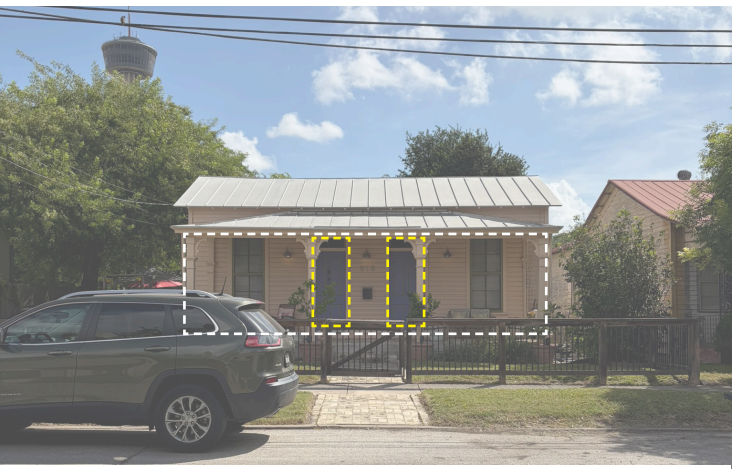
315 Barrera  
32'-0" wide facade  
(2) 3'-0" wide doors  
18.8%

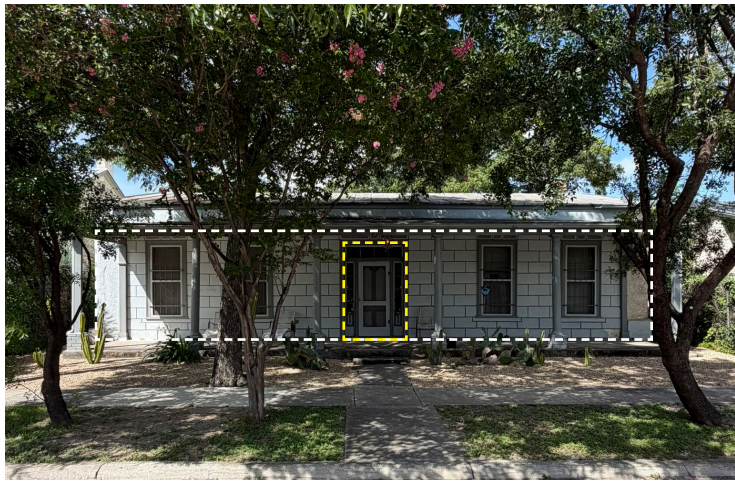
Subject Property: 206 Lavaca (Current Elevation)  
50'-0" wide facade  
5'-7" wide door + sidelites  
11.1%

| 206 Lavaca Existing: | 11.1% |

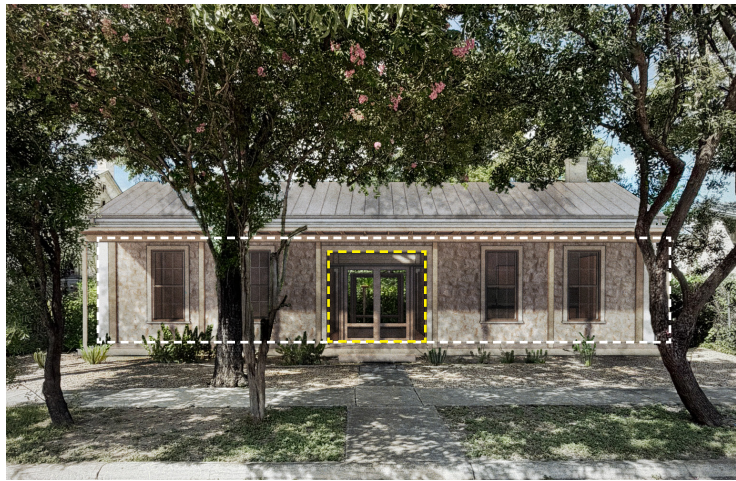
Subject Property: 206 Lavaca (Proposed Elevation)  
50'-0" wide facade  
8'-9" wide door + sidelites  
17.2%

| 206 Lavaca Proposed: | 17.2% |
