## Architectural Design Associates, Inc.

Re: Existing Structure Conditions  
8623 Old Corpus Christi Hwy.

Please see key notes below, applicable to the photos attached:

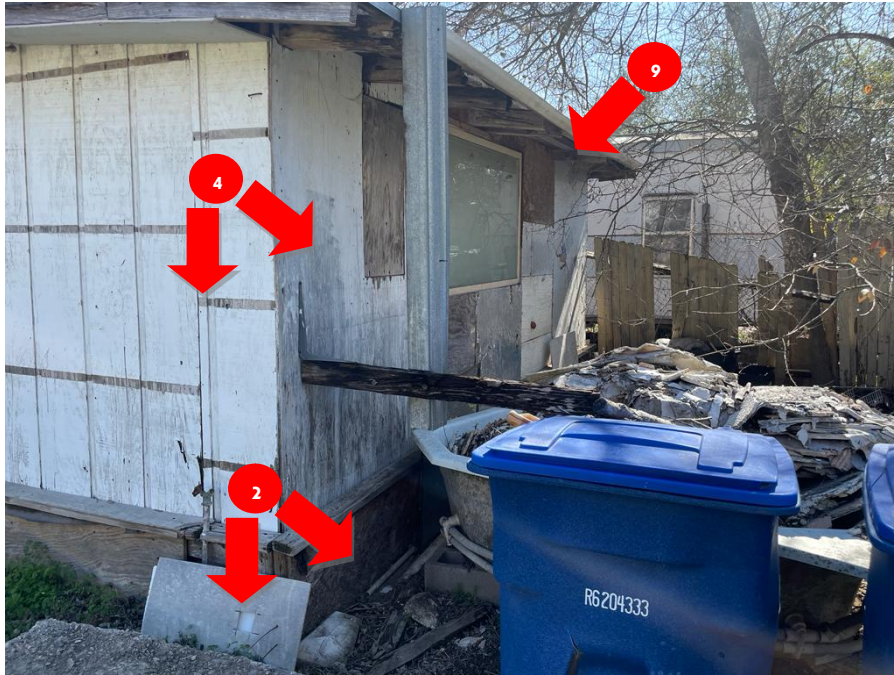
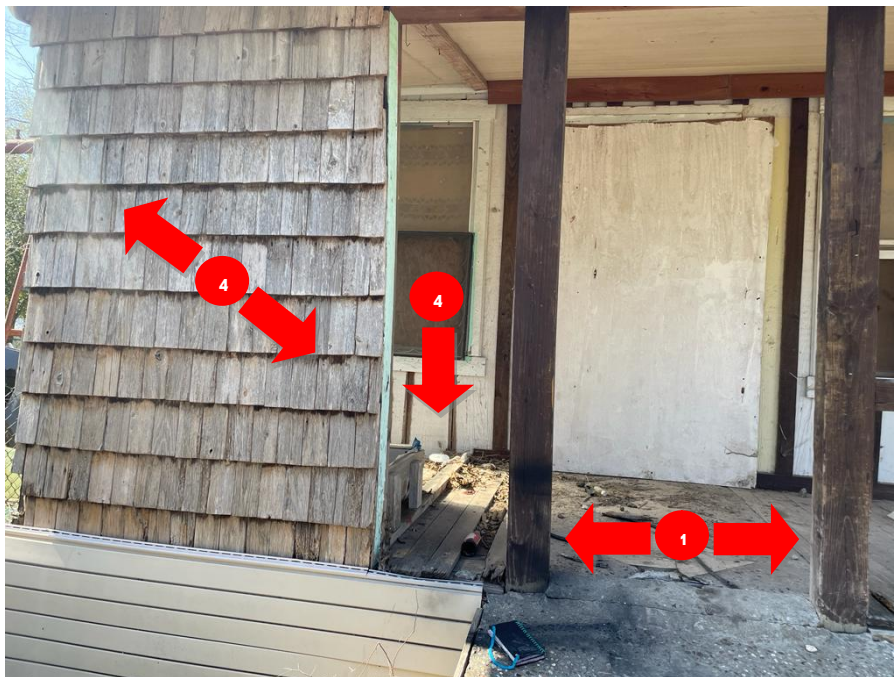
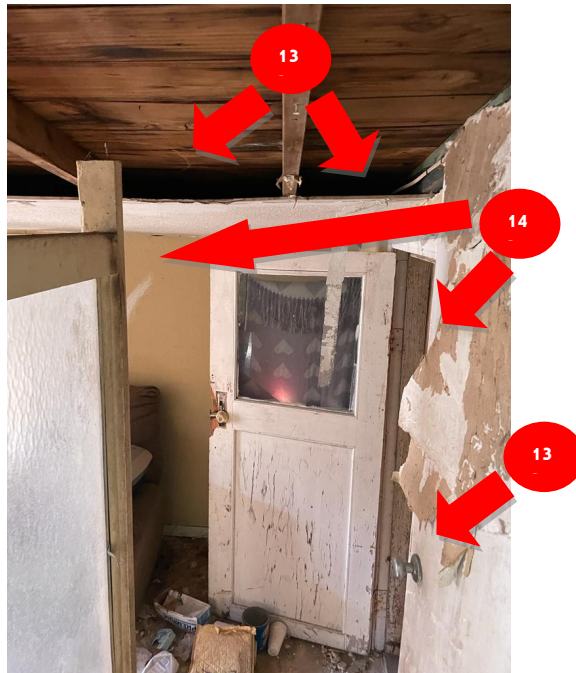
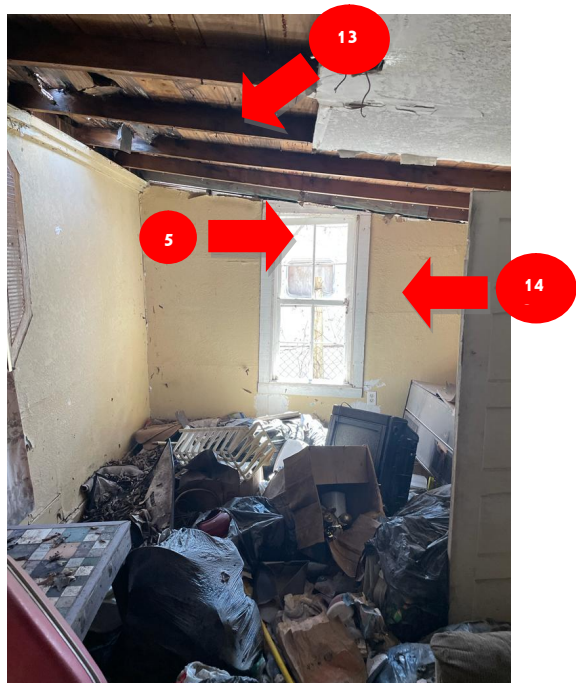
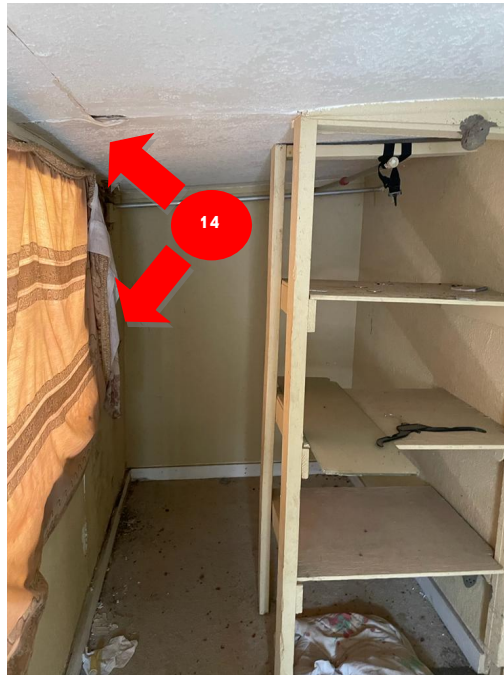
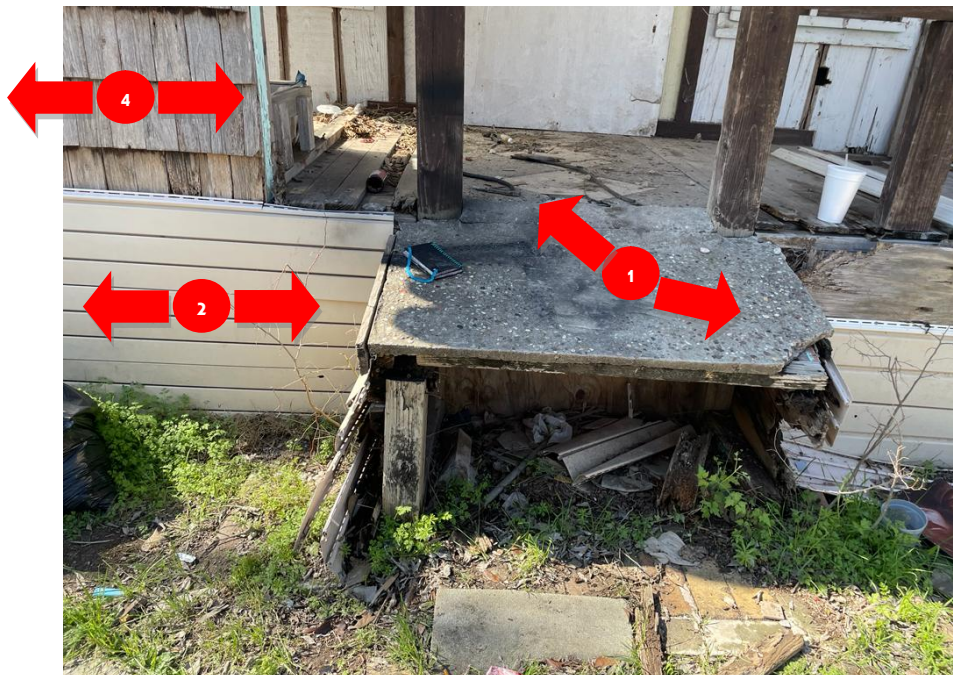
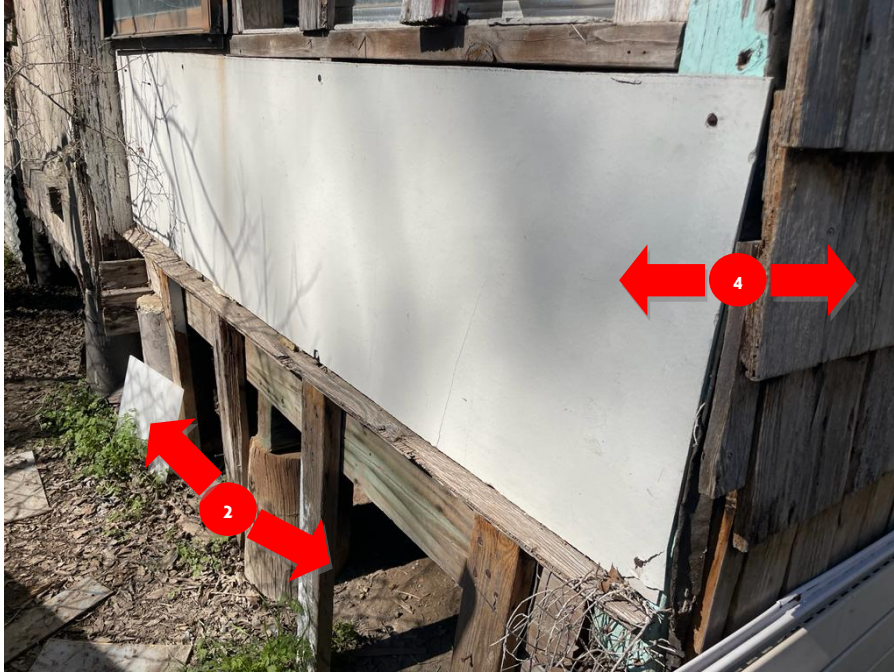
1. Existing wood deck needs to be replaced with foundation post replaced in new IBC code applicable.
2. Skirting below existing finish floor needs to be replaced.
3. Front elevation railings required to be replaced to meet code.
4. Existing siding requires to be replaced and be replaced by one pattern siding. existing siding needs to be removed.
5. Existing windows need to be removed and replaced with required windows meeting the code.
6. Existing structure has several types of roofs and requires new roof.
7. Observation of foundation footings requires replacement with new engineered design.
8. Structure requires new main framing that will meet the current code requirements.
9. Exterior fascia needs to be replaced and installed properly.

10. Existing structure does not have proper wall waterproofing barrier with base flashings. Existing porch needs new sub floor replacement.
11. Existing stucco requires replacement and to be replaced with selected siding.

12. Interior walls need to be properly spaced and plumed according to current code.
13. All existing sheet rock needs replacement with proper tape, float and texture painted.

14. Existing bathroom fixtures need replacement along with faucets and drains.
15. Existing plumbing vents and main drains do not meet current code.
16. Existing main sewer lines need to be replaced and in compliance with current plumbing code.

19. Existing wall within the 1'-6" side yard will have to meet one hour rated wall with no openings on such side.

Note: The above observations of visual inspections, justifies the recommendation of existing residential structure to be removed and demolish. Replacement of a suitable residential structure is present for review and approval.
